# Access Compliance Report

## Public Rights-of-Way

### (Curb Ramps)

Intersection ID: 10169	Main Street: BRICE_ST	Cross Street: MORSON_ST	Location: SW
ADA ID: FEDB2124C2F7	Ramp Type: PerpDiag	Initial Pass/Fail: Fail	Overall Compliance: No
		Severity Score: 12.5

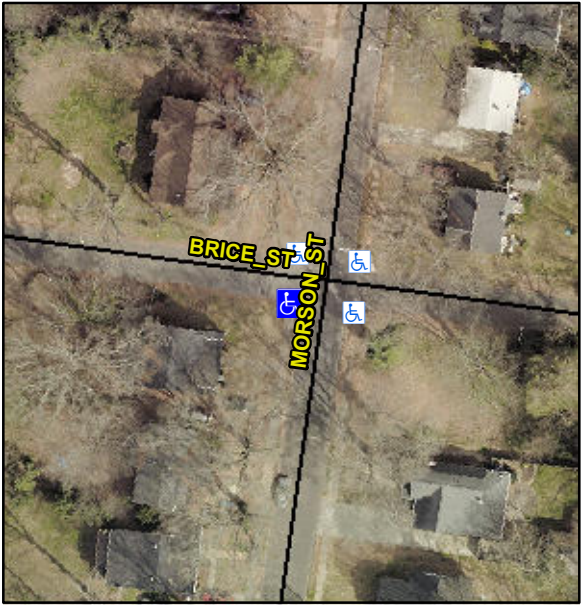
Possible Solutions:		<b>Compliance</b>	<b>Description</b>	<b>Data</b>
	<b>Remove &amp; Replace Curb Ramp With Two New Directional Ramps or Equivalent.</b>		N/A	Ramp Length (in)	25.0
			Yes	Ramp Width (in)	48.0
			N/A	Flare Type LT	N/A
			N/A	Flare Slope LT (%)	N/A
			N/A	Flare Traversable LT?	N/A
			N/A	Landing Length (in)	N/A
			N/A	Landing Width (in)	N/A
			N/A	Landing Slope (%)	N/A
			N/A	Landing X Slope (%)	N/A
			N/A	Landing Curb? (Y/N)	N/A
			N/A	Shared Landing?	N/A
			N/A	Gutter Ponding?	N/A
			N/A	Gutter Lip Ht (in)	2.0
			N/A	Painted X Walk1?	No
				X Walk 1 Direction	To E
			N/A	X Walk 1 Width (in)	N/A
				X Walk 1 Slope (%)	2.9
				X Walk 1 X Slope (%)	0.3
			N/A	Ramp inside XWalk1?	N/A
<p>Surveyor Notes:</p> <p><b>N/A</b></p> <p>PROW/ADA:</p> <p><b>Not Found, R304.2.2</b></p>			N/A	Flare Type RT	N/A
			N/A	Flare Slope RT (%)	N/A

N/A	Flare Traversable RT?	N/A
			N/A	DWS Provided?	N/A
			N/A	DWS Contrast?	N/A
			N/A	DWS Length (in)	N/A
			N/A	DWS Full Width?	N/A
			N/A	DWS Offset (in)	N/A
			N/A	Gutter Slope (%)	N/A
			N/A	Gutter X Slope (%)	N/A
			N/A	Painted X Walk2?	No
				X Walk 2 Direction	To N
			N/A	X Walk 2 Width (in)	N/A
				X Walk 2 Slope (%)	2.5
				X Walk 2 X Slope (%)	3.3
			N/A	Ramp inside XWalk2?	N/A
			N/A	Clear Space?	N/A
			N/A	Clear Space to XWalk (in)	N/A
			N/A	Storm Grate/Utility Hazard?	N/A
				Storm Grate/Utility Type	
<p>Total Cost:</p> <p>\$ 3200.00</p>			N/A		N/A
			Yes	Surface Condition? (G/P)	Good
