Access Compliance Report

Public Rights-of-Way

(Curb Ramps)

Intersection ID: 14495	Main Street: EASTWAY_DR	Cross Street: PINECREST_AV	Location: NW
ADA ID: FEEE0EDD4CB4	Ramp Type: Para	Initial Pass/Fail: Fail	Overall Compliance: No
			Severity Score: 26.25

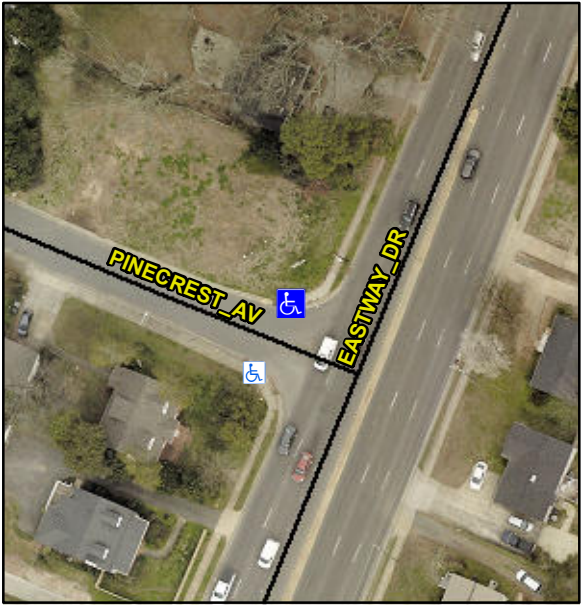
Possible Solutions:		Compliance	Description	Data
	Remove & Replace Entire Ramp.		N/A	Ramp Length LT (in)	58.0
			Yes	Ramp Width LT (in)	73.0
			No	Ramp Slope LT (%)	14.1
			No	Ramp XSlope LT (%)	2.9
			N/A	Landing Length (in)	N/A
			N/A	Landing Width (in)	N/A
			N/A	Landing Slope (%)	N/A
			N/A	Landing X Slope (%)	N/A
			N/A	Landing Curb? (Y/N)	N/A
<p>Surveyor Notes:</p> <p>RT RP < 5%, NO LT SW</p> <p>PROW/ADA:</p> <p>R304.3.2, R304.5.3</p>			N/A	Shared Landing?	N/A
			N/A	Gutter Ponding?	N/A
			N/A	Gutter Lip Ht (in)	N/A
			N/A	Painted X Walk1?	No
				X Walk 1 Direction	To S
			N/A	X Walk 1 Width (in)	N/A
				X Walk 1 Slope (%)	3.1
				X Walk 1 X Slope (%)	3.7
			N/A	Ramp inside XWalk1?	N/A
				Road Slope (%)	N/A
<p>Total Cost:</p> <p>\$ 1600.00</p>			N/A	Road X Slope (%)	N/A
			N/A	Any Obstructions?	N/A
				Obstruction Type

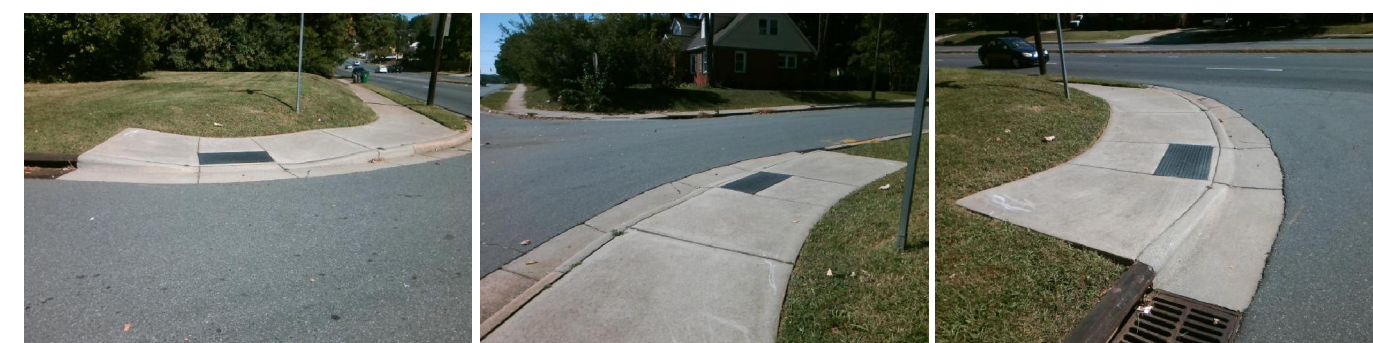
N/A		
<p>Street 1 Name</p> <p>PINECREST AV</p> <p>Stop Condition-Street 1</p> <p>StopSign</p> <p>Street 2 Name</p> <p>N/A</p> <p>Stop Condition-Street 2</p> <p>N/A</p>			N/A	Storm Grate/Utility Hazard?	N/A
				Storm Grate/Utility Type	
			N/A		
<p>Street 1 Name</p> <p>PINECREST AV</p> <p>Stop Condition-Street 1</p> <p>StopSign</p> <p>Street 2 Name</p> <p>N/A</p> <p>Stop Condition-Street 2</p> <p>N/A</p>			N/A	Surface Condition? (G/P)	Good
				Curb Slope (%)	11.9
