Access Compliance Report

Public Rights-of-Way

(Curb Ramps)

Intersection ID: 11483	Main Street: E_17TH_ST	Cross Street: N_CALDWELL_ST	Location: S
ADA ID: FEF0957EE36D	Ramp Type: PerpDiag	Initial Pass/Fail: Fail	Overall Compliance: No
		Severity Score: 35

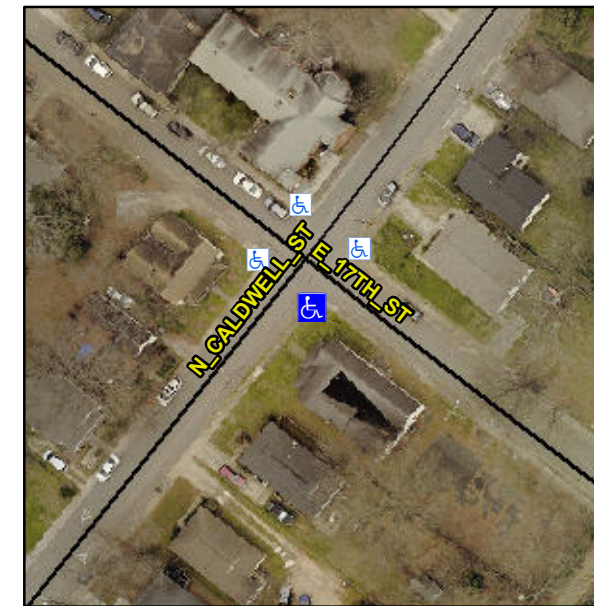
Not Found, R304.5.1, R304.2.2, R304.5.3

Compliance	Description	Data	Compliance	Description	Data
N/A	Ramp Length (in)	53.0	No	Ramp Slope (%)	13.3
No	Ramp Width (in)	38.0	No	Ramp XSlope (%)	4.8
N/A	Flare Type LT	N/A	N/A	Flare Type RT	N/A
N/A	Flare Slope LT (%)	N/A	N/A	Flare Slope RT (%)	N/A
N/A	Flare Traversable LT?	N/A	N/A	Flare Traversable RT?	N/A
N/A	Landing Length (in)	N/A	N/A	DWS Provided?	N/A
N/A	Landing Width (in)	N/A	N/A	DWS Contrast?	N/A
N/A	Landing Slope (%)	N/A	N/A	DWS Length (in)	N/A
N/A	Landing X Slope (%)	N/A	N/A	DWS Full Width?	N/A
N/A	Landing Curb? (Y/N)	N/A	N/A	DWS Offset (in)	N/A
N/A	Shared Landing?	N/A			
N/A	Gutter Ponding?	N/A	N/A	Gutter Slope (%)	N/A
N/A	Gutter Lip Ht (in)	N/A	N/A	Gutter X Slope (%)	N/A
N/A	Painted X Walk1?	No	N/A	Painted X Walk2?	No
	X Walk 1 Direction	To NE		X Walk 2 Direction	To NW
N/A	X Walk 1 Width (in)	N/A	N/A	X Walk 2 Width (in)	N/A
	X Walk 1 Slope (%)	8.2		X Walk 2 Slope (%)	1.3
	X Walk 1 X Slope (%)	0.4		X Walk 2 X Slope (%)	5.2

N/A	Ramp inside XWalk1?	N/A	N/A	Ramp inside XWalk2?	N/A
	Road Slope (%)	3.7	N/A	Clear Space?	N/A
	Road X Slope (%)	2.8	N/A	Clear Space to XWalk (in)	N/A
N/A	Any Obstructions?	N/A	N/A	Storm Grate/Utility Hazard?	N/A
	Obstruction Type			Storm Grate/Utility Type	
		N/A			N/A
			Yes	Surface Condition? (G/P)	Good

Remove & Replace Curb Ramp With Two New Directional Ramps or Equivalent.
