Access Compliance Report

Public Rights-of-Way

(Curb Ramps)

Intersection ID: 2580	Main Street: BENTGRASS_RUN_DR	Cross Street: GREAT_BEAR_CT	Location: E
ADA ID: FF0DA03AE1DF	Ramp Type: PerpDiag	Initial Pass/Fail: Fail	Overall Compliance: No
Severity Score: 35			
Codes/Mitigation Info/Possible Solution		Field Measurements/Component Compliance

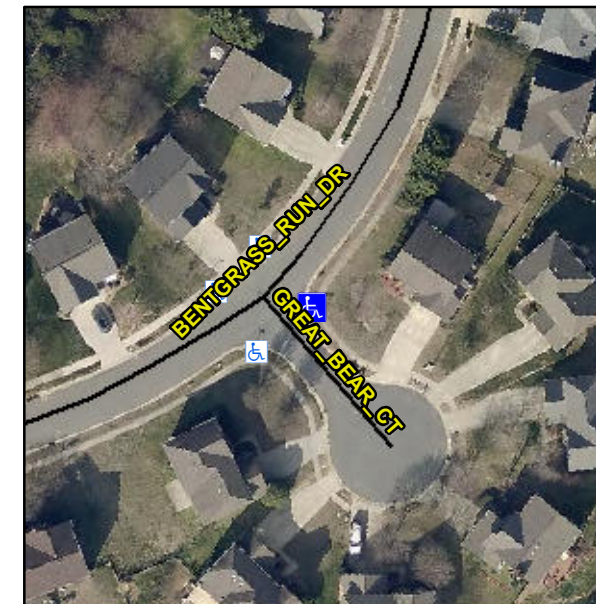
Not Found, R304.5.1, R304.2.2, R304.5.3

Compliance	Description	Data	Compliance	Description	Data
N/A	Ramp Length (in)	48.0	No	Ramp Slope (%)	12.4
No	Ramp Width (in)	47.5	No	Ramp XSlope (%)	4.6
N/A	Flare Type LT	N/A	N/A	Flare Type RT	N/A
N/A	Flare Slope LT (%)	N/A	N/A	Flare Slope RT (%)	N/A
N/A	Flare Traversable LT?	N/A	N/A	Flare Traversable RT?	N/A
N/A	Landing Length (in)	N/A	N/A	DWS Provided?	N/A
N/A	Landing Width (in)	N/A	N/A	DWS Contrast?	N/A
N/A	Landing Slope (%)	N/A	N/A	DWS Length (in)	N/A
N/A	Landing X Slope (%)	N/A	N/A	DWS Full Width?	N/A
N/A	Landing Curb? (Y/N)	N/A	N/A	DWS Offset (in)	N/A
N/A	Shared Landing?	N/A			
N/A	Gutter Ponding?	N/A	N/A	Gutter Slope (%)	N/A
N/A	Gutter Lip Ht (in)	N/A	N/A	Gutter X Slope (%)	N/A
N/A	Painted X Walk1?	No	N/A	Painted X Walk2?	No
	X Walk 1 Direction	To NW		X Walk 2 Direction	To SW
N/A	X Walk 1 Width (in)	N/A	N/A	X Walk 2 Width (in)	N/A
	X Walk 1 Slope (%)	4.0		X Walk 2 Slope (%)	1.9
	X Walk 1 X Slope (%)	2.5		X Walk 2 X Slope (%)	2.7

N/A	Ramp inside XWalk1?	N/A	N/A	Ramp inside XWalk2?	N/A
	Road Slope (%)	4.1	N/A	Clear Space?	N/A
	Road X Slope (%)	2.4	N/A	Clear Space to XWalk (in)	N/A
N/A	Any Obstructions?	N/A	N/A	Storm Grate/Utility Hazard?	N/A
	Obstruction Type			Storm Grate/Utility Type	
		N/A			N/A
			Yes	Surface Condition? (G/P)	Good

Possible Solutions:

Remove & Replace Curb Ramp With Two New Directional Ramps or Equivalent.
