# Access Compliance Report

## Public Rights-of-Way

### (Curb Ramps)

Intersection ID: 49702	Main Street: SCOTTSMAN TRACE DR	Cross Street: MILL RIVER LN	Location: SE
ADA ID: FF131EC40F28	Ramp Type: BlendTrans2	Initial Pass/Fail: Fail	Overall Compliance: No
Severity Score: 25			
Codes/Mitigation Info/Possible Solution		Field Measurements/Component Compliance

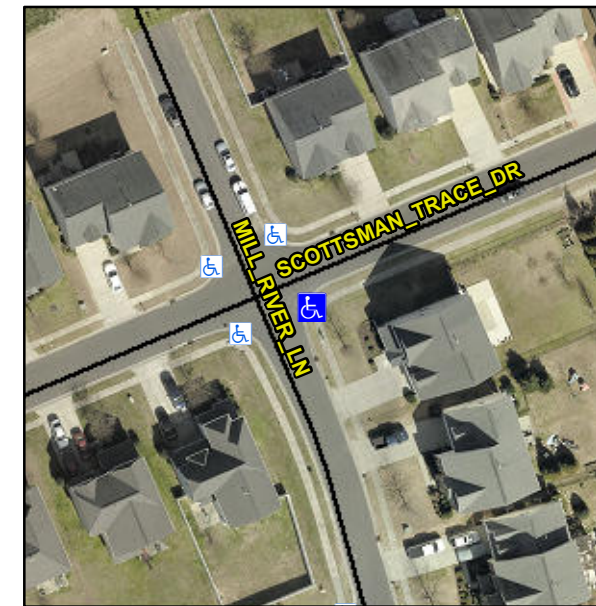
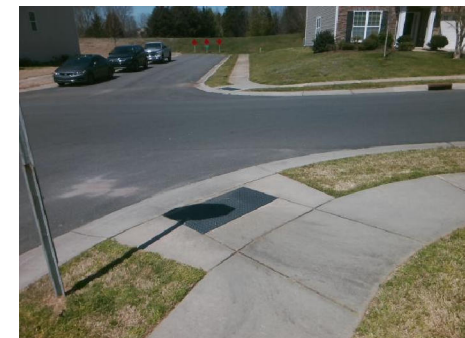
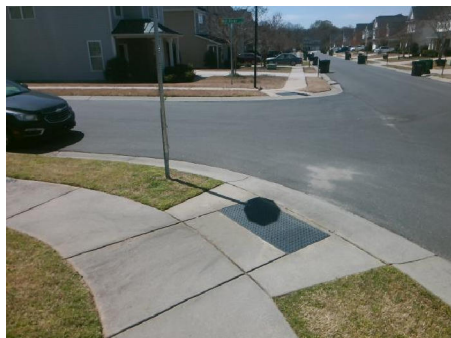
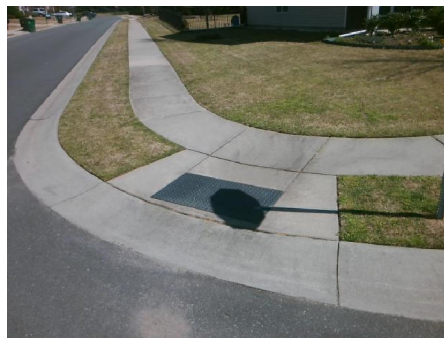
**Not Found, R304.5.3**

Compliance	Description	Data	Compliance	Description	Data
N/A	Ramp Length (in)	95.0	Yes	BlendTrans Slope (%)	3.1
Yes	Ramp Width (in)	48.0	No	BlendTrans XSlope (%)	7.2
N/A	Flare Type LT	N/A	N/A	Flare Type RT	N/A
N/A	Flare Slope LT (%)	N/A	N/A	Flare Slope RT (%)	N/A
N/A	Flare Traversable LT?	N/A	N/A	Flare Traversable RT?	N/A
N/A	Landing Length (in)	N/A	N/A	DWS Provided?	N/A
N/A	Landing Width (in)	N/A	N/A	DWS Contrast?	N/A
N/A	Landing Slope (%)	N/A	N/A	DWS Length (in)	N/A
N/A	Landing X Slope (%)	N/A	N/A	DWS Full Width?	N/A
N/A	Landing Curb? (Y/N)	N/A	N/A	DWS Offset (in)	N/A
N/A	Shared Landing?	N/A			
N/A	Gutter Ponding?	N/A	N/A	Gutter Slope (%)	N/A
N/A	Gutter Lip Ht (in)	N/A	N/A	Gutter X Slope (%)	N/A
N/A	Painted X Walk1?	No	N/A	Painted X Walk2?	No
	X Walk 1 Direction	To NW		X Walk 2 Direction	To SW
	X Walk 1 Width (in)	N/A		X Walk 2 Width (in)	N/A
	X Walk 1 Slope (%)	4.9		X Walk 2 Slope (%)	1.0
	X Walk 1 X Slope (%)	1.9		X Walk 2 X Slope (%)	0.3

N/A	Ramp inside XWalk1?	N/A	N/A	Ramp inside XWalk2?	N/A
	Road Slope (%)	1.3		Clear Space?	N/A
	Road X Slope (%)	0.5	N/A	Clear Space to XWalk (in)	N/A
N/A	Any Obstructions?	N/A	N/A	Storm Grate/Utility Hazard?	N/A
	Obstruction Type			Storm Grate/Utility Type	
		N/A			N/A
			Yes	Surface Condition? (G/P)	Good
			No	Curb Slope (%)	8.0

**Remove & Replace Curb Ramp With Two New Directional Ramps or Equivalent.**
