Access Compliance Report

Public Rights-of-Way

(Curb Ramps)

Intersection ID: 15955	Main Street: IDLEWILD_RD	Cross Street: ROSEHILL_DR	Location: NE
ADA ID: FF328F4689EC	Ramp Type: PerpDiag	Initial Pass/Fail: Fail	Overall Compliance: No
Severity Score: 25			
Codes/Mitigation Info/Possible Solution		Field Measurements/Component Compliance

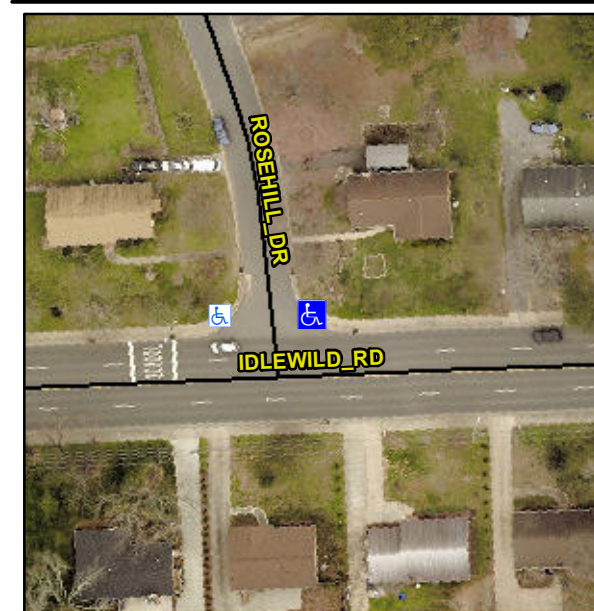
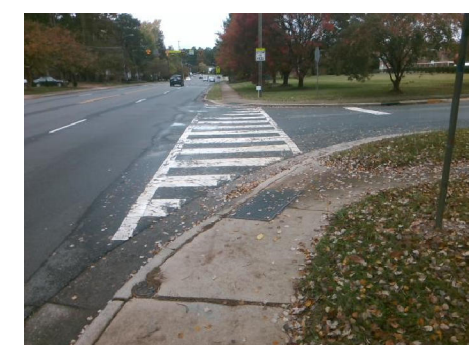
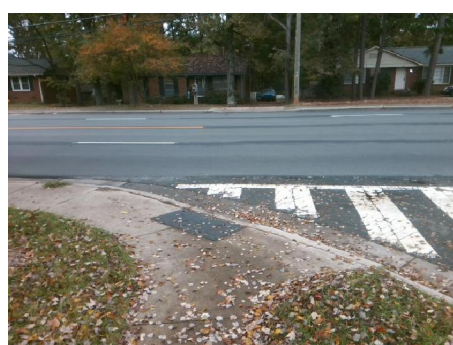
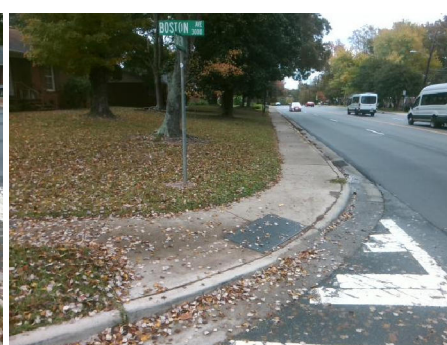
Compliance	Description	Data	Compliance	Description	Data
N/A	Ramp Length (in)	58.0	No	Ramp Slope (%)	12.1
Yes	Ramp Width (in)	48.0	Yes	Ramp XSlope (%)	0.7
N/A	Flare Type LT	N/A	N/A	Flare Type RT	N/A
N/A	Flare Slope LT (%)	N/A	N/A	Flare Slope RT (%)	N/A
N/A	Flare Traversable LT?	N/A	N/A	Flare Traversable RT?	N/A
N/A	Landing Length (in)	N/A	N/A	DWS Provided?	N/A
N/A	Landing Width (in)	N/A	N/A	DWS Contrast?	N/A
N/A	Landing Slope (%)	N/A	N/A	DWS Length (in)	N/A
N/A	Landing X Slope (%)	N/A	N/A	DWS Full Width?	N/A
N/A	Landing Curb? (Y/N)	N/A	N/A	DWS Offset (in)	N/A
N/A	Shared Landing?	N/A			
N/A	Gutter Ponding?	N/A	N/A	Gutter Slope (%)	N/A
N/A	Gutter Lip Ht (in)	N/A	N/A	Gutter X Slope (%)	N/A
N/A	Painted X Walk1?	Yes	N/A	Painted X Walk2?	No
	X Walk 1 Direction	To W		X Walk 2 Direction	To S
N/A	X Walk 1 Width (in)	108.0	N/A	X Walk 2 Width (in)	N/A
	X Walk 1 Slope (%)	2.7		X Walk 2 Slope (%)	1.3
	X Walk 1 X Slope (%)	0.9		X Walk 2 X Slope (%)	0.2

N/A	Ramp inside XWalk1?	Yes	N/A	Ramp inside XWalk2?	N/A
	Road Slope (%)	1.8	N/A	Clear Space?	N/A
	Road X Slope (%)	4.5	N/A	Clear Space to XWalk (in)	N/A
N/A	Any Obstructions?	N/A	N/A	Storm Grate/Utility Hazard?	N/A
	Obstruction Type			Storm Grate/Utility Type	
		N/A			N/A
		Yes		Surface Condition? (G/P)	Good

Remove & Replace Curb Ramp With Two New Directional Ramps or Equivalent.

Not Found, R304.2.2
