# Access Compliance Report

## Public Rights-of-Way

### (Curb Ramps)

Intersection ID: 14720	Main Street: E_5TH_ST	Cross Street: N_DOTGER_AV	Location: E
ADA ID: FF38C5B80DCA	Ramp Type: BlendTrans1	Initial Pass/Fail: Fail	Overall Compliance: No
Severity Score: 1.25			
Codes/Mitigation Info/Possible Solution		Field Measurements/Component Compliance

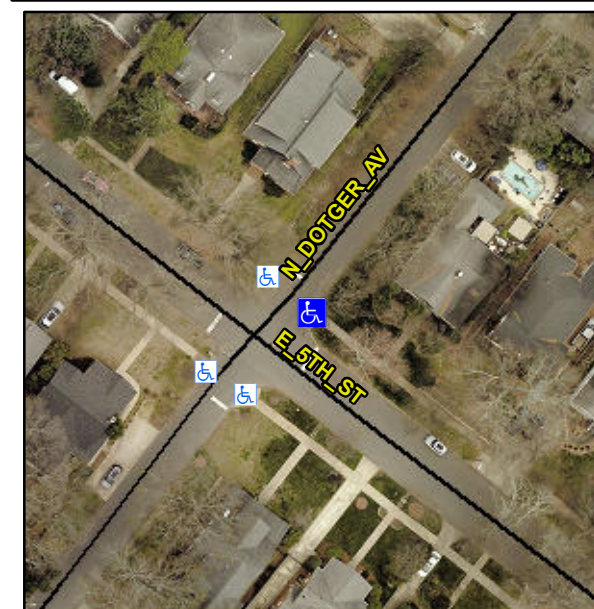
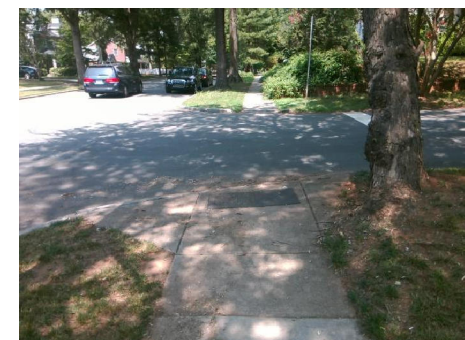
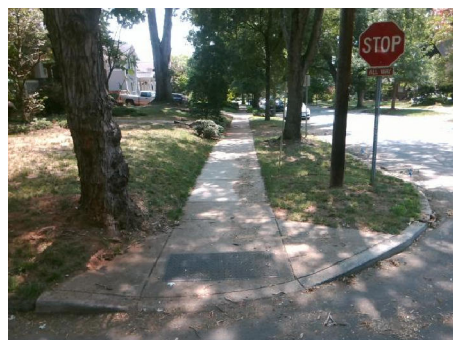
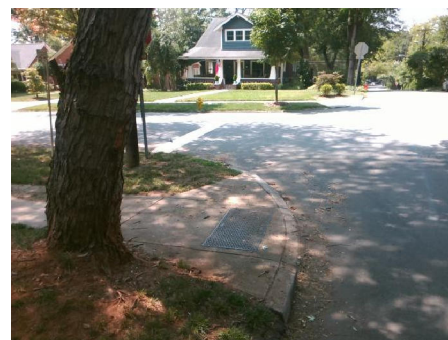
Compliance	Description	Data	Compliance	Description	Data
N/A	Ramp Length (in)	77.0	Yes	BlendTrans Slope (%)	2.2
Yes	Ramp Width (in)	48.0	No	BlendTrans XSlope (%)	3.4
N/A	Flare Type LT	N/A	N/A	Flare Type RT	N/A
N/A	Flare Slope LT (%)	N/A	N/A	Flare Slope RT (%)	N/A
N/A	Flare Traversable LT?	N/A	N/A	Flare Traversable RT?	N/A
N/A	Landing Length (in)	N/A	N/A	DWS Provided?	N/A
N/A	Landing Width (in)	N/A	N/A	DWS Contrast?	N/A
N/A	Landing Slope (%)	N/A	N/A	DWS Length (in)	N/A
N/A	Landing X Slope (%)	N/A	N/A	DWS Full Width?	N/A
N/A	Landing Curb? (Y/N)	N/A	N/A	DWS Offset (in)	N/A
N/A	Shared Landing?	N/A			
N/A	Gutter Ponding?	N/A	N/A	Gutter Slope (%)	N/A
N/A	Gutter Lip Ht (in)	N/A	N/A	Gutter X Slope (%)	N/A
N/A	Painted X Walk1?	No	N/A	Painted X Walk2?	N/A
	X Walk 1 Direction	To NW		X Walk 2 Direction	N/A
	X Walk 1 Width (in)	N/A		X Walk 2 Width (in)	N/A
	X Walk 1 Slope (%)	8.2		X Walk 2 Slope (%)	N/A
	X Walk 1 X Slope (%)	3.7		X Walk 2 X Slope (%)	N/A

N/A	Ramp inside XWalk1?	N/A	N/A	Ramp inside XWalk2?	N/A
	Road Slope (%)	3.7		Clear Space?	N/A
	Road X Slope (%)	8.2	N/A	Clear Space to XWalk (in)	N/A
N/A	Any Obstructions?	N/A	N/A	Storm Grate/Utility Hazard?	N/A
	Obstruction Type			Storm Grate/Utility Type	
		N/A			N/A
			Yes	Surface Condition? (G/P)	Good
			N/A	Curb Slope (%)	5.0

**Remove & Replace Curb Ramp With Two New Directional Ramps or Equivalent.**

**R304.5.3**
