Access Compliance Report

Public Rights-of-Way

(Curb Ramps)

Intersection ID: 44932	Main Street: NATHAN_DR	Cross Street: BRUMIT_LN	Location: NW
ADA ID: FF3E05CCA234	Ramp Type: PerpDiag	Initial Pass/Fail: Fail	Overall Compliance: No
		Severity Score: 10

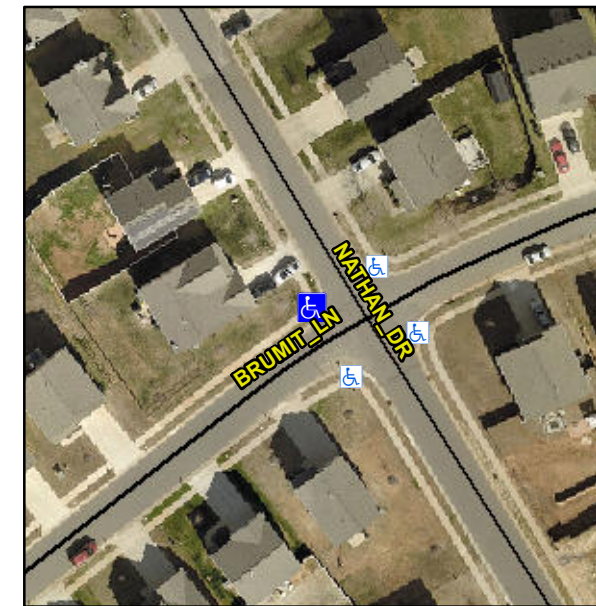
Not Found, R304.5.1, R304.5.3

Compliance	Description	Data	Compliance	Description	Data
N/A	Ramp Length (in)	47.5	Yes	Ramp Slope (%)	7.5
No	Ramp Width (in)	47.0	No	Ramp XSlope (%)	2.4
N/A	Flare Type LT	N/A	N/A	Flare Type RT	N/A
N/A	Flare Slope LT (%)	N/A	N/A	Flare Slope RT (%)	N/A
N/A	Flare Traversable LT?	N/A	N/A	Flare Traversable RT?	N/A
N/A	Landing Length (in)	N/A	N/A	DWS Provided?	N/A
N/A	Landing Width (in)	N/A	N/A	DWS Contrast?	N/A
N/A	Landing Slope (%)	N/A	N/A	DWS Length (in)	N/A
N/A	Landing X Slope (%)	N/A	N/A	DWS Full Width?	N/A
N/A	Landing Curb? (Y/N)	N/A	N/A	DWS Offset (in)	N/A
N/A	Shared Landing?	N/A			
N/A	Gutter Ponding?	N/A	N/A	Gutter Slope (%)	N/A
N/A	Gutter Lip Ht (in)	N/A	N/A	Gutter X Slope (%)	N/A
N/A	Painted X Walk1?	No	N/A	Painted X Walk2?	No
	X Walk 1 Direction	To SE		X Walk 2 Direction	To NE
N/A	X Walk 1 Width (in)	N/A	N/A	X Walk 2 Width (in)	N/A
	X Walk 1 Slope (%)	2.5		X Walk 2 Slope (%)	4.0
	X Walk 1 X Slope (%)	0.6		X Walk 2 X Slope (%)	5.2

N/A	Ramp inside XWalk1?	N/A	N/A	Ramp inside XWalk2?	N/A
	Road Slope (%)	1.5	N/A	Clear Space?	N/A
	Road X Slope (%)	5.6	N/A	Clear Space to XWalk (in)	N/A
N/A	Any Obstructions?	N/A	N/A	Storm Grate/Utility Hazard?	N/A
	Obstruction Type			Storm Grate/Utility Type	
		N/A			N/A
			Yes	Surface Condition? (G/P)	Good

Remove & Replace Curb Ramp With Two New Directional Ramps or Equivalent.
