Intersection ID: 8676	Main Street: HERSHEY_ST	Cross Street: WELLINGFORD_ST	Location:	SE
ADA ID: FF4178842400	Ramp Type: Perp	Initial Pass/Fail: Fail	Overall Compliance: No	Severity Score: 33.75

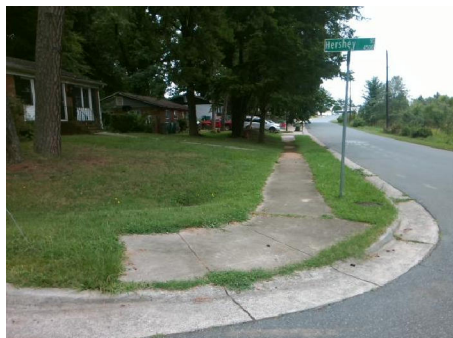
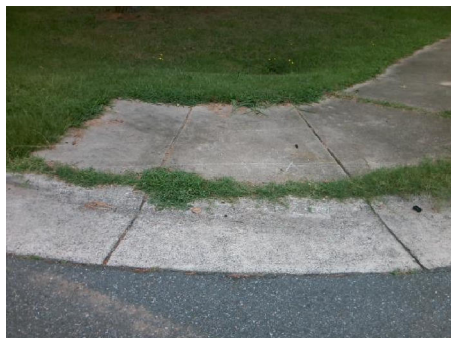
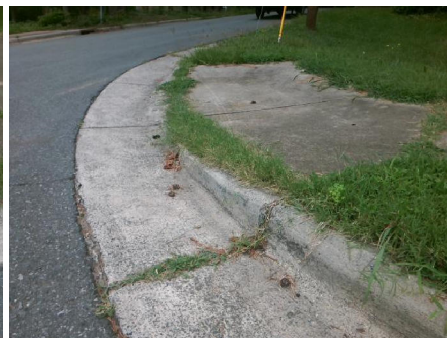
Codes/Mitigation Info/Possible Solution			Field Measurements/Component Compliance					
	Possible Solutions:		Compliance	Description	Data	Compliance	Description	Data
	Remove & Replace Entire Ramp.		N/A	Ramp Length (in)	70.0	Yes	Ramp Slope (%)	7.1
			No	Ramp Width (in)	43.0	No	Ramp XSlope (%)	11.2
			N/A	Flare Type LT	N/A	N/A	Flare Type RT	N/A
			N/A	Flare Slope LT (%)	N/A	N/A	Flare Slope RT (%)	N/A
			N/A	Flare Traversable LT?	N/A	N/A	Flare Traversable RT?	N/A
			N/A	Landing Length (in)	N/A	N/A	DWS Provided?	N/A
			N/A	Landing Width (in)	N/A	N/A	DWS Contrast?	N/A
			N/A	Landing Slope (%)	N/A	N/A	DWS Length (in)	N/A
			N/A	Landing X Slope (%)	N/A	N/A	DWS Full Width?	N/A
Surveyor Notes:		N/A	N/A	Landing Curb? (Y/N)	N/A	N/A	DWS Offset (in)	N/A
PROW/ADA:		Not Found, R304.5.1, R304.5.3	N/A	Shared Landing?	N/A			
			N/A	Gutter Ponding?	N/A	N/A	Gutter Slope (%)	N/A
			N/A	Gutter Lip Ht (in)	N/A	N/A	Gutter X Slope (%)	N/A

N/A	Painted X Walk1?	No	N/A	Painted X Walk2?	N/A
				X Walk 1 Direction	To N		X Walk 2 Direction	N/A
			N/A	X Walk 1 Width (in)	N/A	N/A	X Walk 2 Width (in)	N/A
				X Walk 1 Slope (%)	2.8		X Walk 2 Slope (%)	N/A
				X Walk 1 X Slope (%)	8.5		X Walk 2 X Slope (%)	N/A
			N/A	Ramp inside XWalk1?	N/A	N/A	Ramp inside XWalk2?	N/A
				Road Slope (%)	N/A	N/A	Clear Space?	N/A
				Road X Slope (%)	N/A	N/A	Clear Space to XWalk (in)	N/A
			N/A	Any Obstructions?	N/A	N/A	Storm Grate/Utility Hazard?	N/A
				Obstruction Type			Storm Grate/Utility Type	
					N/A			N/A
						Yes	Surface Condition? (G/P)	Good
Street 1 Name	HERSHEY ST							
Stop Condition-Street 2	StopSign							
Street 2 Name	N/A							
Stop Condition-Street 1	N/A							
Total Cost:			\$	1850.00
