Access Compliance Report Public Rights-of-Way (Curb Ramps)

Intersection ID: 19223 Main Street: PARK RD Cross Street: VILLA HERMOSA DR Location: NW **Overall Compliance: No Severity Score:** ADA ID: FF4569165904 Ramp Type: PerpDiag Initial Pass/Fail: Fail 12.5

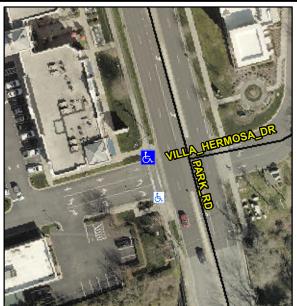
VILLA HERMOSA DR Street 1 Name Stop Condition-Street 2 None **PARK RD** Street 2 Name Stop Condition-Street 1 None Possible Solutions: Compliance Description N/A Remove & Replace Curb Ramp With Two New Directional Ramps or Yes Equivalent. Surveyor Notes: N/A PROW/ADA: Not Found, R304.2.2
