# Access Compliance Report

## Public Rights-of-Way

### (Curb Ramps)

| Intersection ID: 53912 | Main Street: BRITTONDALE LN | Cross Street: PINYON_PINE LN | Location: SW |

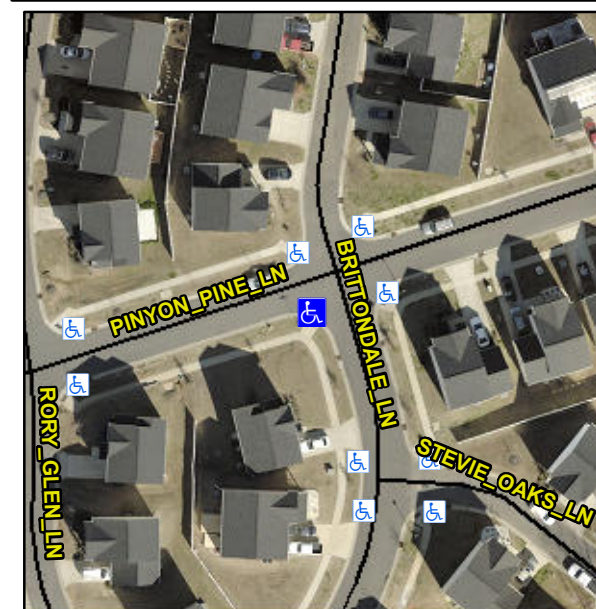
**Not Found, R304.5.1**

| Compliance | Description | Data | Compliance | Description | Data |
|---|---|---|---|---|---|
| No | Ramp Width (in) | 47.5 | Yes | BlendTrans XSlope (%) | 1.5 |
| | | | No | Curb Slope (%) | 14.7 |

**Remove & Replace Curb Ramp With Two New Directional Ramps or Equivalent.**

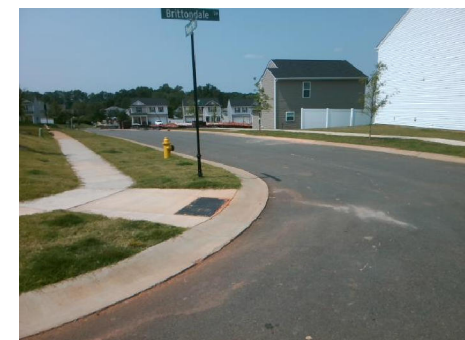
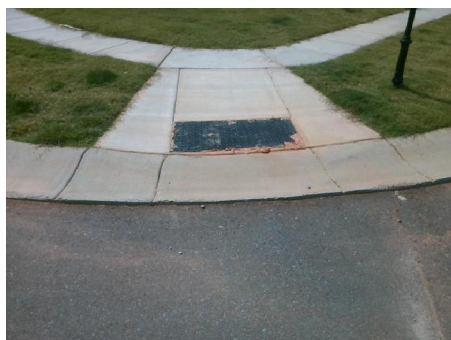
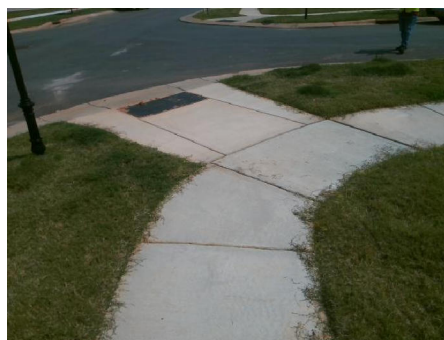
| ADA ID: FF48094D7609 | Ramp Type: BlendTrans1 | Initial Pass/Fail: Fail | Overall Compliance: No |
| Severity Score: 8.75 | | | |
