Access Compliance Report

Public Rights-of-Way

(Curb Ramps)

| Intersection ID: 27431 | Main Street: BALLANTYNE COMMONS PY | Cross Street: RUSHMORE DR | Location: NE |

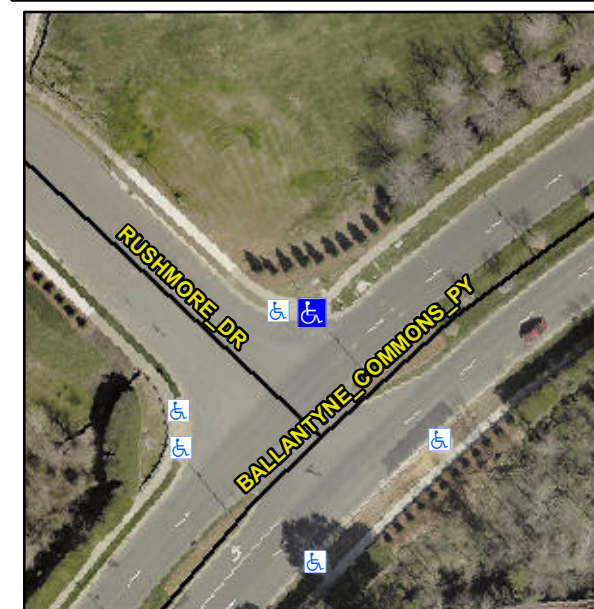
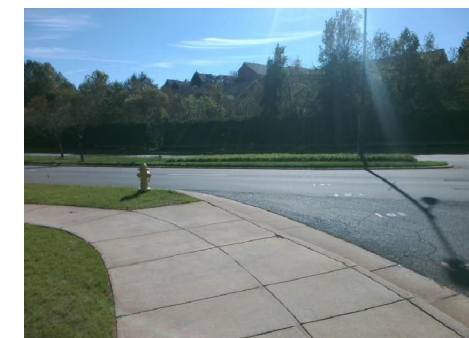
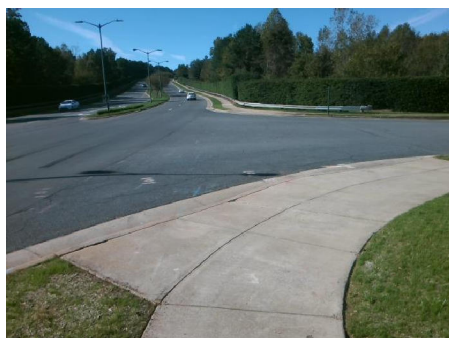
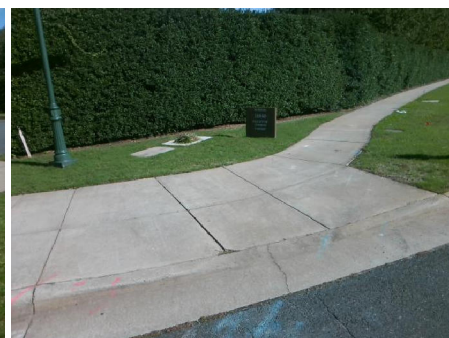
| ADA ID: FF4BF01142D5 | Ramp Type: Perp | Initial Pass/Fail: Fail | Overall Compliance: No |
| Severity Score: 8.75 | | | |

Not Found, R304.5.1

| Compliance | Description | Data | Compliance | Description | Data |
|---|---|---|---|---|---|
| No | Ramp Width (in) | 45.0 | Yes | Ramp XSlope (%) | 2.0 |

Possible Solutions:

Remove & Replace Entire Ramp.

Total Cost: \$ 1850.00
