# Access Compliance Report

## Public Rights-of-Way

### (Curb Ramps)

Intersection ID: 43365	Main Street: EASTFIELD_RD	Cross Street: SIMONTON_DR	Location: E
ADA ID: FF5433832FBB	Ramp Type: Perp	Initial Pass/Fail: Fail	Overall Compliance: No
Severity Score: 26.25			
Codes/Mitigation Info/Possible Solution		Field Measurements/Component Compliance

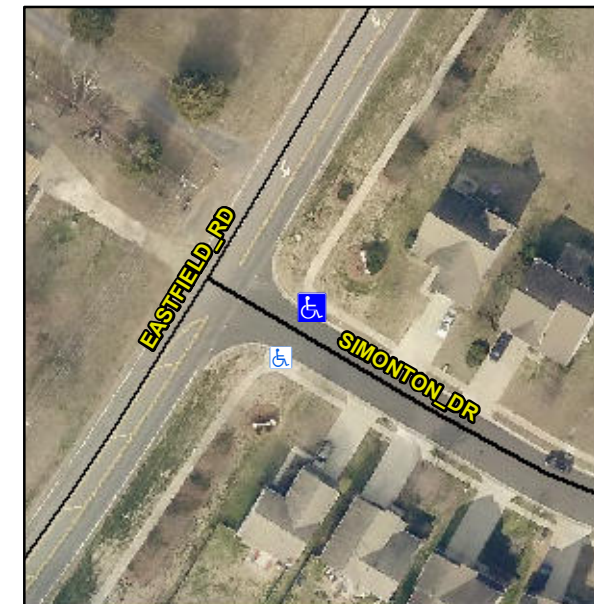
**Not Found, R304.2.2, R304.5.3**

Compliance	Description	Data	Compliance	Description	Data
N/A	Ramp Length (in)	54.0	No	Ramp Slope (%)	12.4
Yes	Ramp Width (in)	48.0	No	Ramp XSlope (%)	2.3
N/A	Flare Type LT	N/A	N/A	Flare Type RT	N/A
N/A	Flare Slope LT (%)	N/A	N/A	Flare Slope RT (%)	N/A
N/A	Flare Traversable LT?	N/A	N/A	Flare Traversable RT?	N/A
N/A	Landing Length (in)	N/A	N/A	DWS Provided?	N/A
N/A	Landing Width (in)	N/A	N/A	DWS Contrast?	N/A
N/A	Landing Slope (%)	N/A	N/A	DWS Length (in)	N/A
N/A	Landing X Slope (%)	N/A	N/A	DWS Full Width?	N/A
N/A	Landing Curb? (Y/N)	N/A	N/A	DWS Offset (in)	N/A
N/A	Shared Landing?	N/A			
N/A	Gutter Ponding?	N/A	N/A	Gutter Slope (%)	N/A
N/A	Gutter Lip Ht (in)	N/A	N/A	Gutter X Slope (%)	N/A
N/A	Painted X Walk1?	No	N/A	Painted X Walk2?	N/A
	X Walk 1 Direction	To SW		X Walk 2 Direction	N/A
N/A	X Walk 1 Width (in)	N/A	N/A	X Walk 2 Width (in)	N/A
	X Walk 1 Slope (%)	5.2		X Walk 2 Slope (%)	N/A
	X Walk 1 X Slope (%)	2.1		X Walk 2 X Slope (%)	N/A

N/A	Ramp inside XWalk1?	N/A	N/A	Ramp inside XWalk2?	N/A
	Road Slope (%)	N/A	N/A	Clear Space?	N/A
	Road X Slope (%)	N/A	N/A	Clear Space to XWalk (in)	N/A
N/A	Any Obstructions?	N/A	N/A	Storm Grate/Utility Hazard?	N/A
	Obstruction Type			Storm Grate/Utility Type	
		N/A			N/A
		Yes		Surface Condition? (G/P)	Good

**Remove & Replace Entire Ramp.**

Total Cost: \$ 1850.00
