Access Compliance Report

Public Rights-of-Way

(Curb Ramps)

Intersection ID: 8889	Main Street: BENNETT_ST	Cross Street: N_TRYON_ST	Location: NW
ADA ID: FF56192983F5	Ramp Type: PerpDiag	Initial Pass/Fail: Fail	Overall Compliance: No
		Severity Score: 10

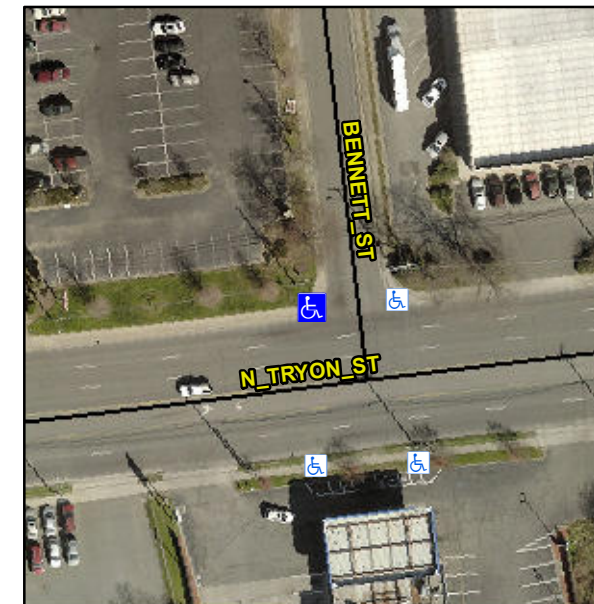
Not Found, R304.5.1, R304.5.3

Compliance	Description	Data	Compliance	Description	Data
N/A	Ramp Length (in)	60.0	Yes	Ramp Slope (%)	5.1
No	Ramp Width (in)	40.0	No	Ramp XSlope (%)	4.4
N/A	Flare Type LT	N/A	N/A	Flare Type RT	N/A
N/A	Flare Slope LT (%)	N/A	N/A	Flare Slope RT (%)	N/A
N/A	Flare Traversable LT?	N/A	N/A	Flare Traversable RT?	N/A
N/A	Landing Length (in)	N/A	N/A	DWS Provided?	N/A
N/A	Landing Width (in)	N/A	N/A	DWS Contrast?	N/A
N/A	Landing Slope (%)	N/A	N/A	DWS Length (in)	N/A
N/A	Landing X Slope (%)	N/A	N/A	DWS Full Width?	N/A
N/A	Landing Curb? (Y/N)	N/A	N/A	DWS Offset (in)	N/A
N/A	Shared Landing?	N/A			
N/A	Gutter Ponding?	N/A	N/A	Gutter Slope (%)	N/A
N/A	Gutter Lip Ht (in)	1.0	N/A	Gutter X Slope (%)	N/A
N/A	Painted X Walk1?	No	N/A	Painted X Walk2?	No
	X Walk 1 Direction	To S		X Walk 2 Direction	To E
N/A	X Walk 1 Width (in)	N/A	N/A	X Walk 2 Width (in)	N/A
	X Walk 1 Slope (%)	4.4		X Walk 2 Slope (%)	2.0
	X Walk 1 X Slope (%)	1.8		X Walk 2 X Slope (%)	5.8

N/A	Ramp inside XWalk1?	N/A	N/A	Ramp inside XWalk2?	N/A
	Road Slope (%)	1.4	N/A	Clear Space?	N/A
	Road X Slope (%)	10.7	N/A	Clear Space to XWalk (in)	N/A
N/A	Any Obstructions?	N/A	N/A	Storm Grate/Utility Hazard?	N/A
	Obstruction Type			Storm Grate/Utility Type	
		N/A			N/A
			Yes	Surface Condition? (G/P)	Good

Remove & Replace Curb Ramp With Two New Directional Ramps or Equivalent.
