Access Compliance Report

Public Rights-of-Way (Curb Ramps)

Intersection ID: 7036	Main Street: BEATTIES_FORD_RD	Cross Street: MCALLISTER_DR	Location: SE
ADA ID: FF609A6E3CBC	Ramp Type: PerpDiag	Initial Pass/Fail: Fail	Overall Compliance: No
Severity Score: 21.25			
Codes/Mitigation Info/Possible Solution		Field Measurements/Component Compliance

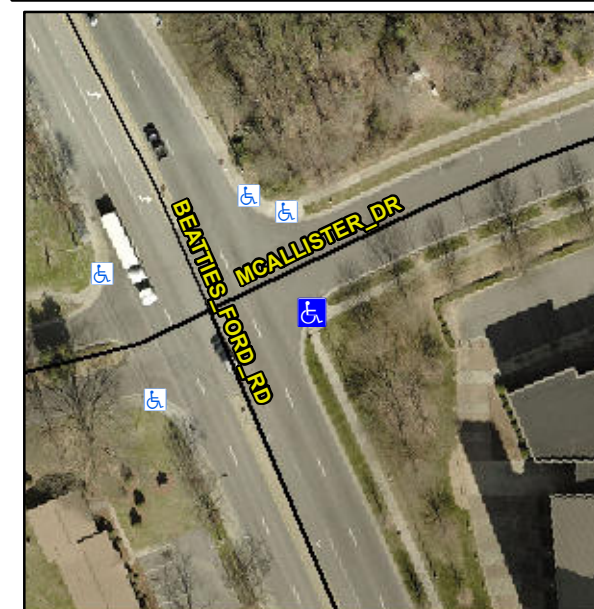
Not Found, R304.5.1, R304.2.2

Compliance	Description	Data	Compliance	Description	Data
N/A	Ramp Length (in)	35.0	No	Ramp Slope (%)	9.4
No	Ramp Width (in)	44.0	Yes	Ramp XSlope (%)	0.5
N/A	Flare Type LT	N/A	N/A	Flare Type RT	N/A
N/A	Flare Slope LT (%)	N/A	N/A	Flare Slope RT (%)	N/A
N/A	Flare Traversable LT?	N/A	N/A	Flare Traversable RT?	N/A
N/A	Landing Length (in)	N/A	N/A	DWS Provided?	N/A
N/A	Landing Width (in)	N/A	N/A	DWS Contrast?	N/A
N/A	Landing Slope (%)	N/A	N/A	DWS Length (in)	N/A
N/A	Landing X Slope (%)	N/A	N/A	DWS Full Width?	N/A
N/A	Landing Curb? (Y/N)	N/A	N/A	DWS Offset (in)	N/A
N/A	Shared Landing?	N/A			
N/A	Gutter Ponding?	N/A	N/A	Gutter Slope (%)	N/A
N/A	Gutter Lip Ht (in)	N/A	N/A	Gutter X Slope (%)	N/A
N/A	Painted X Walk1?	No	N/A	Painted X Walk2?	No
	X Walk 1 Direction	To N		X Walk 2 Direction	To W
N/A	X Walk 1 Width (in)	N/A	N/A	X Walk 2 Width (in)	N/A
	X Walk 1 Slope (%)	0.1		X Walk 2 Slope (%)	0.1
	X Walk 1 X Slope (%)	1.5		X Walk 2 X Slope (%)	1.7

N/A	Ramp inside XWalk1?	N/A	N/A	Ramp inside XWalk2?	N/A
	Road Slope (%)	0.5	N/A	Clear Space?	N/A
	Road X Slope (%)	0.6	N/A	Clear Space to XWalk (in)	N/A
N/A	Any Obstructions?	N/A	N/A	Storm Grate/Utility Hazard?	N/A
	Obstruction Type			Storm Grate/Utility Type	
		N/A			N/A
		Yes		Surface Condition? (G/P)	Good

Remove & Replace Curb Ramp With Two New Directional Ramps or Equivalent.

Total Cost: \$ 3200.00
