# Access Compliance Report

## Public Rights-of-Way

### (Curb Ramps)

Intersection ID: 26096	Main Street: PARK_RD	Cross Street: BLUE_HERON_DR	Location: NW
ADA ID: FF6294ED51E0	Ramp Type: Perp	Initial Pass/Fail: Fail	Overall Compliance: No
		Severity Score: 12.5

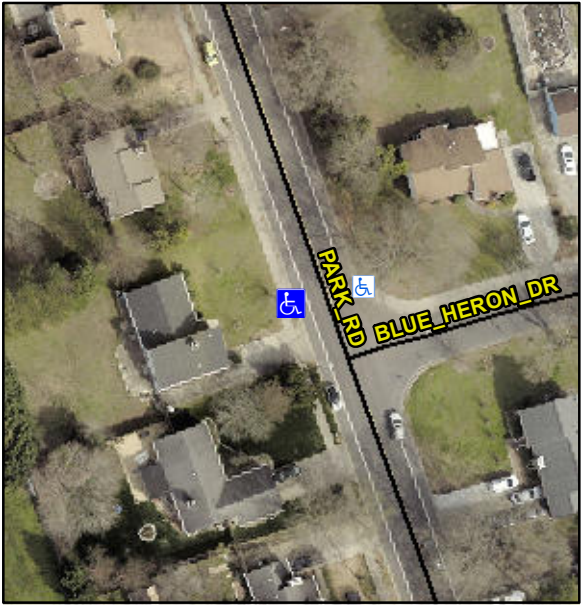
Possible Solutions:		<b>Compliance</b>	<b>Description</b>	<b>Data</b>
	<b>Remove &amp; Replace Entire Ramp.</b>		<b>No</b>	Ramp Length (in)	86.0
			<b>Yes</b>	Ramp Width (in)	48.0
			<b>N/A</b>	Flare Type LT	N/A
			<b>N/A</b>	Flare Slope LT (%)	N/A
			<b>N/A</b>	Flare Traversable LT?	N/A
			<b>N/A</b>	Landing Length (in)	N/A
			<b>N/A</b>	Landing Width (in)	N/A
			<b>N/A</b>	Landing Slope (%)	N/A
			<b>N/A</b>	Landing X Slope (%)	N/A
<p>Surveyor Notes:</p> <p><b>N/A</b></p> <p>PROW/ADA:</p> <p><b>Not Found, R304.2.2</b></p>			<b>N/A</b>	Flare Type RT	N/A
			<b>N/A</b>	Flare Slope RT (%)	N/A
			<b>N/A</b>	Flare Traversable RT?	N/A
			<b>N/A</b>	DWS Provided?	N/A
			<b>N/A</b>	DWS Contrast?	N/A
			<b>N/A</b>	DWS Length (in)	N/A
			<b>N/A</b>	DWS Full Width?	N/A
			<b>N/A</b>	DWS Offset (in)	N/A
			<b>N/A</b>	Shared Landing?	N/A

<b>N/A</b>	Gutter Ponding?	N/A
			<b>N/A</b>	Gutter Lip Ht (in)	N/A
			<b>N/A</b>	Painted X Walk1?	No
				X Walk 1 Direction	To E
			<b>N/A</b>	X Walk 1 Width (in)	N/A
				X Walk 1 Slope (%)	5.2
				X Walk 1 X Slope (%)	1.9
			<b>N/A</b>	Ramp inside XWalk1?	N/A
			<b>N/A</b>	Road Slope (%)	N/A
			<b>N/A</b>	Road X Slope (%)	N/A
			<b>N/A</b>	Any Obstructions?	N/A
				Obstruction Type	
			<b>N/A</b>		
			<b>N/A</b>		
			<b>N/A</b>		
			<b>N/A</b>		
			<b>N/A</b>		
			<b>N/A</b>		
			<b>N/A</b>		
			<b>N/A</b>		
			<b>N/A</b>		
Total Cost:		\$ 1850.00			
			<b>N/A</b>		
			<b>Yes</b>	Surface Condition? (G/P)	Good
