Access Compliance Report

Public Rights-of-Way

(Curb Ramps)

Intersection ID: 5175	Main Street: FROSTMOOR_PL	Cross Street: HAYBRIDGE_RD	Location: NE
ADA ID: FF7CF6F44FE4	Ramp Type: PerpDiag	Initial Pass/Fail: Fail	Overall Compliance: No
		Severity Score: 8.75

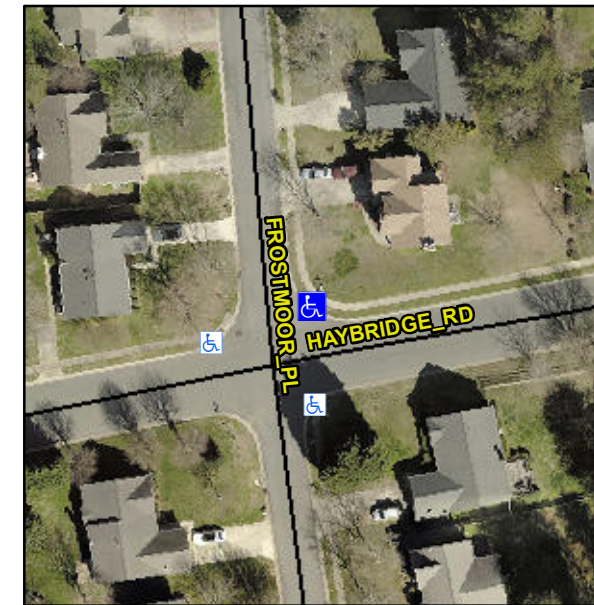
Not Found, R304.5.1

Compliance	Description	Data	Compliance	Description	Data
N/A	Ramp Length (in)	48.0	Yes	Ramp Slope (%)	5.1
No	Ramp Width (in)	47.0	Yes	Ramp XSlope (%)	1.4
N/A	Flare Type LT	N/A	N/A	Flare Type RT	N/A
N/A	Flare Slope LT (%)	N/A	N/A	Flare Slope RT (%)	N/A
N/A	Flare Traversable LT?	N/A	N/A	Flare Traversable RT?	N/A
N/A	Landing Length (in)	N/A	N/A	DWS Provided?	N/A
N/A	Landing Width (in)	N/A	N/A	DWS Contrast?	N/A
N/A	Landing Slope (%)	N/A	N/A	DWS Length (in)	N/A
N/A	Landing X Slope (%)	N/A	N/A	DWS Full Width?	N/A
N/A	Landing Curb? (Y/N)	N/A	N/A	DWS Offset (in)	N/A
N/A	Shared Landing?	N/A			
N/A	Gutter Ponding?	N/A	N/A	Gutter Slope (%)	N/A
N/A	Gutter Lip Ht (in)	N/A	N/A	Gutter X Slope (%)	N/A
N/A	Painted X Walk1?	No	N/A	Painted X Walk2?	No
	X Walk 1 Direction	To W		X Walk 2 Direction	To S
N/A	X Walk 1 Width (in)	N/A	N/A	X Walk 2 Width (in)	N/A
	X Walk 1 Slope (%)	5.5		X Walk 2 Slope (%)	4.0
	X Walk 1 X Slope (%)	2.3		X Walk 2 X Slope (%)	4.6

N/A	Ramp inside XWalk1?	N/A	N/A	Ramp inside XWalk2?	N/A
	Road Slope (%)	0.7	N/A	Clear Space?	N/A
	Road X Slope (%)	7.2	N/A	Clear Space to XWalk (in)	N/A
N/A	Any Obstructions?	N/A	N/A	Storm Grate/Utility Hazard?	N/A
	Obstruction Type			Storm Grate/Utility Type	
		N/A			N/A
		Yes		Surface Condition? (G/P)	Good

Remove & Replace Curb Ramp With Two New Directional Ramps or Equivalent.
