# Access Compliance Report

## Public Rights-of-Way

### (Curb Ramps)

Intersection ID: N/A	Main Street: ROCK_ISLAND_RD	Cross Street: SAW_MILL_RD	Location: E
ADA ID: FF7FE366A1E6	Ramp Type: BlendTrans2	Initial Pass/Fail: Fail	Overall Compliance: No
		Severity Score: 21.25

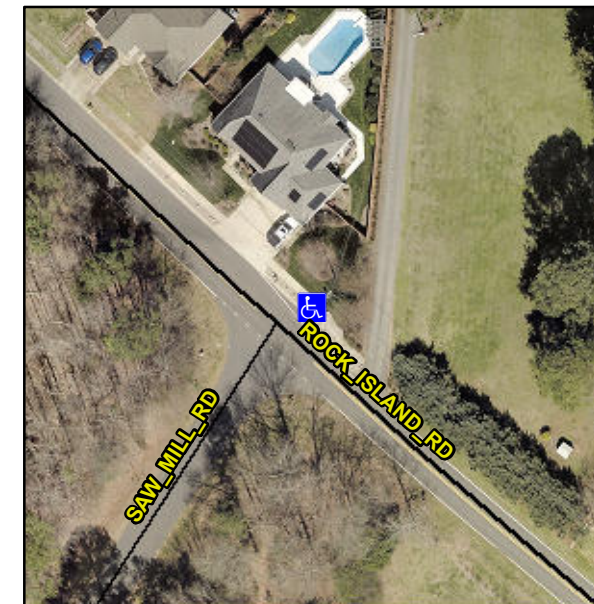
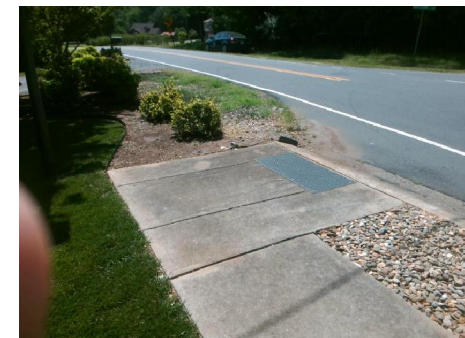
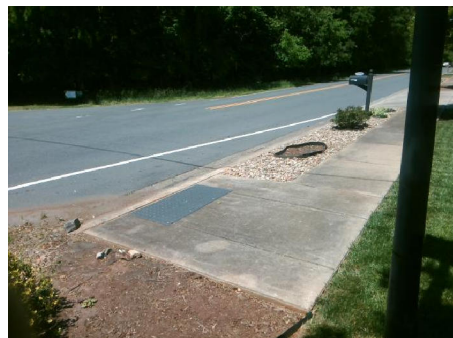
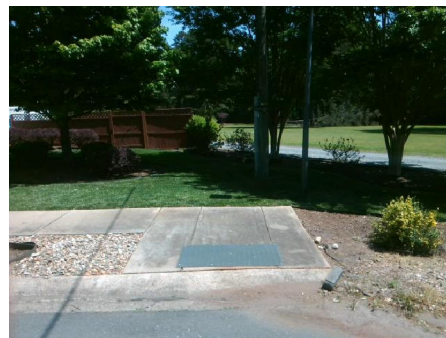
**Not Found, R304.5.1, R304.5.3**

Compliance	Description	Data	Compliance	Description	Data
N/A	Ramp Length (in)	93.0	Yes	BlendTrans Slope (%)	2.6
No	Ramp Width (in)	41.5	No	BlendTrans XSlope (%)	5.5
N/A	Flare Type LT	N/A	N/A	Flare Type RT	N/A
N/A	Flare Slope LT (%)	N/A	N/A	Flare Slope RT (%)	N/A
N/A	Flare Traversable LT?	N/A	N/A	Flare Traversable RT?	N/A
N/A	Landing Length (in)	N/A	N/A	DWS Provided?	N/A
N/A	Landing Width (in)	N/A	N/A	DWS Contrast?	N/A
N/A	Landing Slope (%)	N/A	N/A	DWS Length (in)	N/A
N/A	Landing X Slope (%)	N/A	N/A	DWS Full Width?	N/A
N/A	Landing Curb? (Y/N)	N/A	N/A	DWS Offset (in)	N/A
N/A	Shared Landing?	N/A			
N/A	Gutter Ponding?	N/A	N/A	Gutter Slope (%)	N/A
N/A	Gutter Lip Ht (in)	N/A	N/A	Gutter X Slope (%)	N/A
N/A	Painted X Walk1?	No	N/A	Painted X Walk2?	N/A
	X Walk 1 Direction	To SW		X Walk 2 Direction	N/A
	X Walk 1 Width (in)	N/A		X Walk 2 Width (in)	N/A
	X Walk 1 Slope (%)	3.6		X Walk 2 Slope (%)	N/A
	X Walk 1 X Slope (%)	3.5		X Walk 2 X Slope (%)	N/A

N/A	Ramp inside XWalk1?	N/A	N/A	Ramp inside XWalk2?	N/A
	Road Slope (%)	3.5		Clear Space?	N/A
	Road X Slope (%)	3.6	N/A	Clear Space to XWalk (in)	N/A
N/A	Any Obstructions?	N/A	N/A	Storm Grate/Utility Hazard?	N/A
	Obstruction Type			Storm Grate/Utility Type	
		N/A			N/A
			Yes	Surface Condition? (G/P)	Good
			No	Curb Slope (%)	41.6

**Remove & Replace Curb Ramp With Two New Directional Ramps or Equivalent.**
