Access Compliance Report

Public Rights-of-Way

(Curb Ramps)

Intersection ID: 13085	Main Street: MORRIS_FIELD_DR	Cross Street: CAPITOL_DR	Location: SE
ADA ID: FF8C21B7B5DA	Ramp Type: Perp	Initial Pass/Fail: Fail	Overall Compliance: No
Severity Score: 8.75			
Codes/Mitigation Info/Possible Solution		Field Measurements/Component Compliance

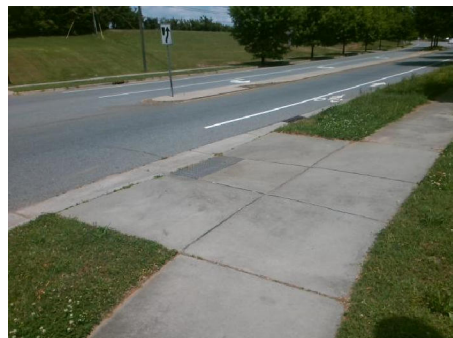
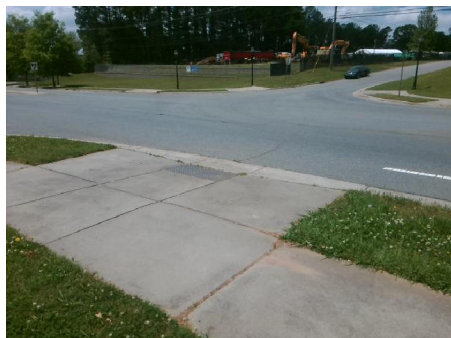
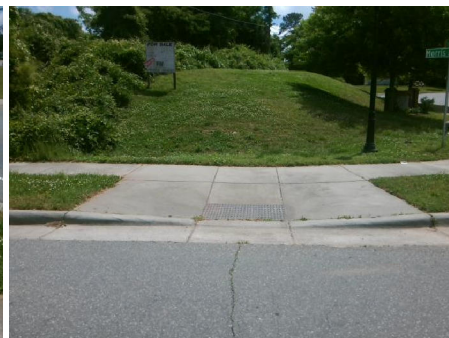
Not Found, R304.5.1

Compliance	Description	Data	Compliance	Description	Data
N/A	Ramp Length (in)	71.0	Yes	Ramp Slope (%)	5.3
No	Ramp Width (in)	47.0	Yes	Ramp XSlope (%)	0.1
N/A	Flare Type LT	N/A	N/A	Flare Type RT	N/A
N/A	Flare Slope LT (%)	N/A	N/A	Flare Slope RT (%)	N/A
N/A	Flare Traversable LT?	N/A	N/A	Flare Traversable RT?	N/A
N/A	Landing Length (in)	N/A	N/A	DWS Provided?	N/A
N/A	Landing Width (in)	N/A	N/A	DWS Contrast?	N/A
N/A	Landing Slope (%)	N/A	N/A	DWS Length (in)	N/A
N/A	Landing X Slope (%)	N/A	N/A	DWS Full Width?	N/A
N/A	Landing Curb? (Y/N)	N/A	N/A	DWS Offset (in)	N/A
N/A	Shared Landing?	N/A			
N/A	Gutter Ponding?	N/A	N/A	Gutter Slope (%)	N/A
N/A	Gutter Lip Ht (in)	N/A	N/A	Gutter X Slope (%)	N/A
N/A	Painted X Walk1?	No	N/A	Painted X Walk2?	N/A
	X Walk 1 Direction	To NW		X Walk 2 Direction	N/A
N/A	X Walk 1 Width (in)	N/A	N/A	X Walk 2 Width (in)	N/A
	X Walk 1 Slope (%)	1.6		X Walk 2 Slope (%)	N/A
	X Walk 1 X Slope (%)	1.7		X Walk 2 X Slope (%)	N/A

N/A	Ramp inside XWalk1?	N/A	N/A	Ramp inside XWalk2?	N/A
	Road Slope (%)	N/A	N/A	Clear Space?	N/A
	Road X Slope (%)	N/A	N/A	Clear Space to XWalk (in)	N/A
N/A	Any Obstructions?	N/A	N/A	Storm Grate/Utility Hazard?	N/A
	Obstruction Type			Storm Grate/Utility Type	
		N/A			N/A
			Yes	Surface Condition? (G/P)	Good

Remove & Replace Entire Ramp.
