Access Compliance Report

Public Rights-of-Way

(Curb Ramps)

Intersection ID: 15459	Main Street: CONISTON_PL	Cross Street: S_KINGS_DR	Location: SE
ADA ID: FFA5BFA87B92	Ramp Type: Directional1	Initial Pass/Fail: Pass	Overall Compliance: No
Severity Score: 0.25			
Codes/Mitigation Info/Possible Solution		Field Measurements/Component Compliance

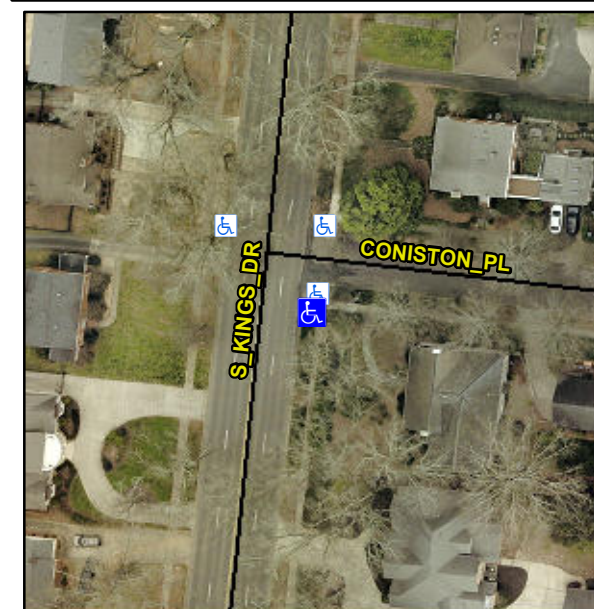
Compliance	Description	Data	Compliance	Description	Data
N/A	Ramp Length (in)	73.0	No	Grade Break?	No
Yes	Ramp Width (in)	52.0	N/A	Grade Break Slope (%)	6.5
Yes	Ramp Slope (%)	6.4	N/A	Grade Break XSlope (%)	1.4
No	Ramp XSlope (%)	2.1			
N/A	Flare Type LT	N/A	Yes	Flare Type RT	N/A
Yes	Flare Slope LT (%)	2.2	N/A	Flare Slope RT (%)	N/A
N/A	Flare Traversable LT?	Yes	N/A	Flare Traversable RT?	No
Yes	Landing Length (in)	51.0	Yes	DWS Provided?	Yes
Yes	Landing Width (in)	53.0	Yes	DWS Contrast?	Yes
Yes	Landing Slope (%)	0.7	Yes	DWS Length (in)	24.0
Yes	Landing X Slope (%)	0.9	Yes	DWS Full Width?	Yes
N/A	Landing Curb? (Y/N)	N/A	Yes	DWS Offset LT (in)	1.0
N/A	Shared Landing?	Yes	Yes	DWS Offset RT (in)	19.0
No	Gutter Ponding?	Yes	Yes	Gutter Slope (%)	4.6
Yes	Gutter Lip Ht (in)	0.0	Yes	Gutter X Slope (%)	0.5
N/A	Painted X Walk1?	No		Road Slope (%)	3.6
	X Walk 1 Direction	To W		Road X Slope (%)	0.8
	X Walk 1 Width (in)	N/A		Clear Space?	Yes

X Walk 1 Slope (%)	3.6	N/A	Clear Space to XWalk (in)	N/A
	X Walk 1 X Slope (%)	0.8	Yes	Storm Grate/Utility Hazard?	No
N/A	Ramp inside XWalk1?	N/A		Storm Grate/Utility Type	
Yes	Any Obstructions?	No			N/A
	Obstruction Type		Yes	Surface Condition? (G/P)	Good
			N/A	Curb Slope (%)	5.7

**Remove & Replace Entire Ramp.
Gutter Ponding Observed.**

R304.5.3, R304.5.2, R302.7

\$ 2100.00
