# Access Compliance Report

## Public Rights-of-Way

### (Curb Ramps)

Intersection ID: 18339	Main Street: BEECHGROVE_CT	Cross Street: MCLAUGHLIN_DR	Location: S
ADA ID: FFB7CDCE6A45	Ramp Type: PerpDiag	Initial Pass/Fail: Fail	Overall Compliance: No
Severity Score: 8.75			
Codes/Mitigation Info/Possible Solution		Field Measurements/Component Compliance

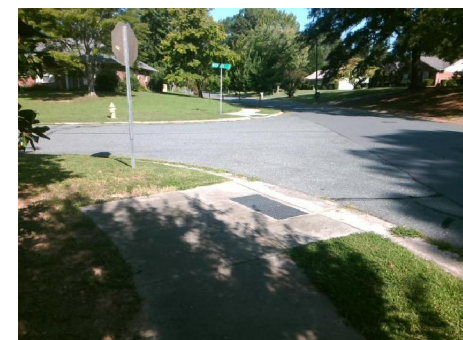
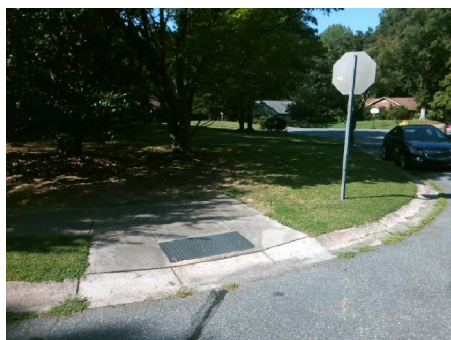
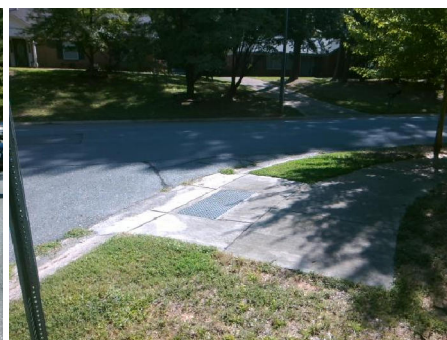
Compliance	Description	Data	Compliance	Description	Data
N/A	Ramp Length (in)	48.0	Yes	Ramp Slope (%)	7.9
No	Ramp Width (in)	45.5	Yes	Ramp XSlope (%)	0.1
N/A	Flare Type LT	N/A	N/A	Flare Type RT	N/A
N/A	Flare Slope LT (%)	N/A	N/A	Flare Slope RT (%)	N/A
N/A	Flare Traversable LT?	N/A	N/A	Flare Traversable RT?	N/A
N/A	Landing Length (in)	N/A	N/A	DWS Provided?	N/A
N/A	Landing Width (in)	N/A	N/A	DWS Contrast?	N/A
N/A	Landing Slope (%)	N/A	N/A	DWS Length (in)	N/A
N/A	Landing X Slope (%)	N/A	N/A	DWS Full Width?	N/A
N/A	Landing Curb? (Y/N)	N/A	N/A	DWS Offset (in)	N/A
N/A	Shared Landing?	N/A			
N/A	Gutter Ponding?	N/A	N/A	Gutter Slope (%)	N/A
N/A	Gutter Lip Ht (in)	N/A	N/A	Gutter X Slope (%)	N/A
N/A	Painted X Walk1?	No	N/A	Painted X Walk2?	No
	X Walk 1 Direction	To NE		X Walk 2 Direction	To NW
N/A	X Walk 1 Width (in)	N/A	N/A	X Walk 2 Width (in)	N/A
	X Walk 1 Slope (%)	4.8		X Walk 2 Slope (%)	5.0
	X Walk 1 X Slope (%)	1.4		X Walk 2 X Slope (%)	6.0

N/A	Ramp inside XWalk1?	N/A	N/A	Ramp inside XWalk2?	N/A
	Road Slope (%)	0.9	N/A	Clear Space?	N/A
	Road X Slope (%)	4.3	N/A	Clear Space to XWalk (in)	N/A
N/A	Any Obstructions?	N/A	N/A	Storm Grate/Utility Hazard?	N/A
	Obstruction Type			Storm Grate/Utility Type	
		N/A			N/A
			Yes	Surface Condition? (G/P)	Good

**Remove & Replace Curb Ramp With Two New Directional Ramps or Equivalent.**
