Access Compliance Report Public Rights-of-Way (Curb Ramps)

| Intersection ID: 14678 Main Street: E_W_T_HARRIS_BV Cross Street: WALLACE_AV Location: | | | | | | | | | SW |
| ADA ID: FFC4488197F5 | 7F5 Ramp Type: Perp | | | Initial Pass/Fail: Fail Overall Compliance: No | | | | o Severity Score: | 12.5 |

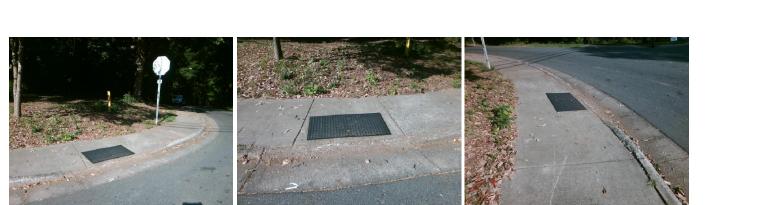
| Intersection ID: 14678 Main Street: E_W_T_HARRIS_BV Cross Street: WALLACE_AV Location: | | | | | | | | | SW |
|---|---|---|---|--|---|---|---|---|---|
| and the group of the second | A CAR | Remove & Replace Entire Ramp | | N/A | Ramp Length (in) | 57.5 | No | Ramp Slope (%) | 10.1 |
| | B C CE | PROW/ADA: | I | N/A | Gutter Ponding? | N/A | N/A | Gutter Slope (%) | N/A |
| | | Not Found, R304.2.2 | 1 | N/A | Gutter Lip Ht (in) | N/A | N/A | Gutter X Slope (%) | N/A |

| Intersection ID: 14678 Main Street: E_W_T_HARRIS_BV Cross Street: WALLACE_AV Location: | | | | | | | | | SW |
|---|---|---|---|--|---|---|---|---|---|
| | | Total Cost: \$ | 850.00 | | Obstruction Type | | | Storm Grate/Utility Type | |
