Access Compliance Report

Public Rights-of-Way

(Curb Ramps)

| Intersection ID: 14272 | Main Street: BROOKHILL_RD | Cross Street: VILLAGE_CT | Location: SE |

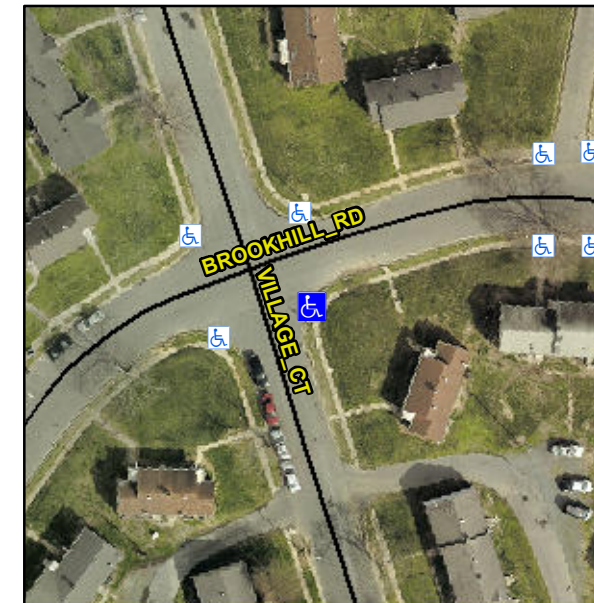
| ADA ID: FFC9DD76D747 | Ramp Type: PerpDiag | Initial Pass/Fail: Fail | Overall Compliance: No |

Not Found, R304.2.2, R304.5.3

| Compliance | Description | Data | Compliance | Description | Data |
|---|---|---|---|---|---|
| N/A | Ramp Length (in) | 87.0 | No | Ramp Slope (%) | 9.1 |
| Yes | Ramp Width (in) | 48.0 | No | Ramp XSlope (%) | 2.4 |

Remove & Replace Curb Ramp With Two New Directional Ramps or Equivalent.
