# Access Compliance Report

## Public Rights-of-Way

### (Curb Ramps)

Intersection ID: 53746	Main Street: SPRINGWOOD_ESTATE_DR	Cross Street: CANTERBURY_CASTLE_DR	Location: NE
ADA ID: FFD64A6609CB	Ramp Type: Perp	Initial Pass/Fail: Fail	Overall Compliance: No
Severity Score: 33.75			
Codes/Mitigation Info/Possible Solution		Field Measurements/Component Compliance

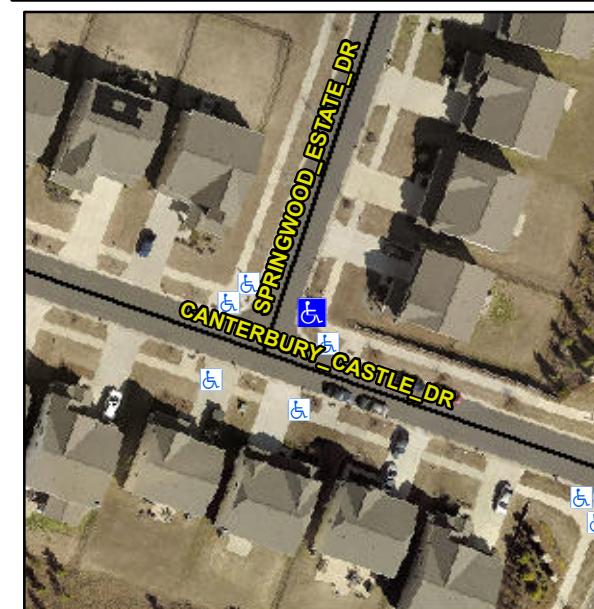
**Not Found, R304.5.1, R304.2.2, R304.5.3**

Compliance	Description	Data	Compliance	Description	Data
N/A	Ramp Length (in)	103.0	No	Ramp Slope (%)	9.0
No	Ramp Width (in)	45.5	No	Ramp XSlope (%)	5.9
N/A	Flare Type LT	N/A	N/A	Flare Type RT	N/A
N/A	Flare Slope LT (%)	N/A	N/A	Flare Slope RT (%)	N/A
N/A	Flare Traversable LT?	N/A	N/A	Flare Traversable RT?	N/A
N/A	Landing Length (in)	N/A	N/A	DWS Provided?	N/A
N/A	Landing Width (in)	N/A	N/A	DWS Contrast?	N/A
N/A	Landing Slope (%)	N/A	N/A	DWS Length (in)	N/A
N/A	Landing X Slope (%)	N/A	N/A	DWS Full Width?	N/A
N/A	Landing Curb? (Y/N)	N/A	N/A	DWS Offset (in)	N/A
N/A	Shared Landing?	N/A			
N/A	Gutter Ponding?	N/A	N/A	Gutter Slope (%)	N/A
N/A	Gutter Lip Ht (in)	N/A	N/A	Gutter X Slope (%)	N/A
N/A	Painted X Walk1?	No	N/A	Painted X Walk2?	N/A
	X Walk 1 Direction	To NW		X Walk 2 Direction	N/A
N/A	X Walk 1 Width (in)	N/A	N/A	X Walk 2 Width (in)	N/A
	X Walk 1 Slope (%)	0.5		X Walk 2 Slope (%)	N/A
	X Walk 1 X Slope (%)	6.9		X Walk 2 X Slope (%)	N/A

N/A	Ramp inside XWalk1?	N/A	N/A	Ramp inside XWalk2?	N/A
	Road Slope (%)	N/A	N/A	Clear Space?	N/A
	Road X Slope (%)	N/A	N/A	Clear Space to XWalk (in)	N/A
N/A	Any Obstructions?	N/A	N/A	Storm Grate/Utility Hazard?	N/A
	Obstruction Type			Storm Grate/Utility Type	
		N/A			N/A
			Yes	Surface Condition? (G/P)	Good

**Remove & Replace Entire Ramp.**

Total Cost: \$ 1850.00
