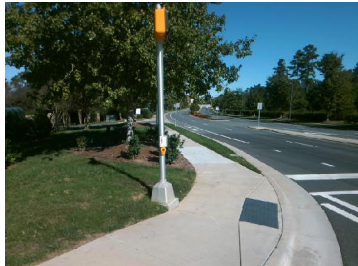
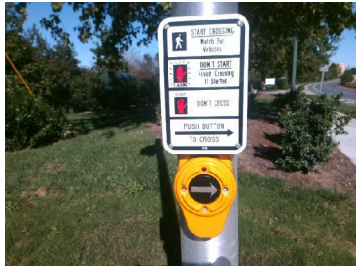
PROW/ADA: TMUTCD 4e.08, R406.2, R209.1, MUTCD 4e.10

| MUTCD Compliance | |
|---|---|
| No B 1 DistanceTo Curb (in) | 85.0 |

Possible Solutions: Replace Signal Push Button With APS Button on New Post. Remove & Relocate Sign.
