Access Compliance Report Public Rights-of-Way (Pedestrian Signals)

Intersection ID: N/A **Main Street:** Cross Street: N/A Location: N/A

Signal Type: One Push Button-APS Severity Score: BTN 1:N/A BTN 2: N/A No BTN: ADA ID: 34845C2BFE35 **Overall Compliance: No** N/A

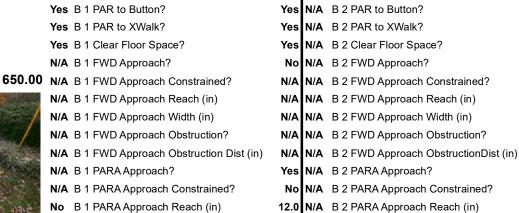
| | | N/A B 1 PARA Approach Width (in) | N/A N/A | B 2 PARA Approach Width (in) | N/A |
|---|---|---|--|---|---|
| Yes B 1 Extended Press Feature? | Yes N/A B 2 Extended Press Feature? N/A | No B 1 DistanceTo Curb (in) | 112.0 N/A | B 2 DistanceTo Curb (in) | N/A |

Possible Solutions: Replace Signal Push Button With APS Button on New Post. Remove & Relocate Sign.

PROW/ADA: TMUTCD 4e.08. R404.7.3. R209.1, MUTCD 4e.10
