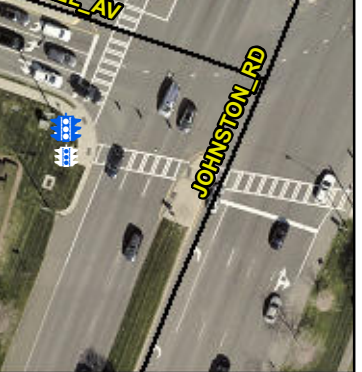
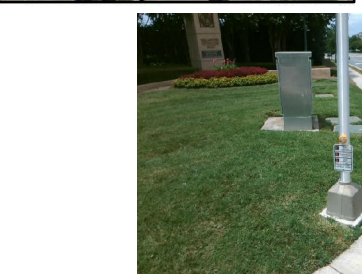
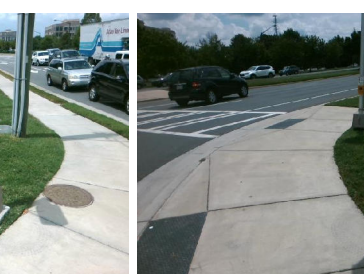
| | | | | Possible Solutions: Replace Signal Push Button With APS Button on New Post. Remove & Relocate Sign. | | | |
|--|---|---|---|--|---|---|---|
| Is Button 1 APS or Non-APS? | NonAPS | Is Button 2 APS or Non-APS? | N/A | Yes | B 1 Clear Xing Direction? | ClearlyMarked | N/A |
| N/A B 1 VibroTact Arrow? | No | N/A B 2 VibroTact Arrow? | N/A | | B 1 Crossing Direction | To NE | N/A |
| N/A B 1 VibroTact Parallel to Xing? | No | N/A B 2 VibroTact Parallel to Xing? | N/A | Yes | B 1 DistanceTo XWalk (in) | 0.0 | N/A |
| N/A B 1 VibroTact Contrast | No | N/A B 2 VibroTact Contrast | N/A | No | B 1 DistanceTo Curb (in) | 101.0 | N/A |
| N/A B 1 Pilot Light? | No | N/A B 2 Pilot Light? | N/A | Yes | B 1 Diameter (in) | 2.0 | N/A |
| N/A B 1 Pilot Light Illumination? | No | N/A B 2 Pilot Light Illumination? | N/A | | | | |
| N/A B 1 Verbal Walk Cycle? | No | N/A B 2 Verbal Walk Cycle? | N/A | | | | |
| N/A B 1 Verbal Message Audible? | No | N/A B 2 Verbal Message Audible? | N/A | | | | |
| N/A B 1 Locator Tone? | No | N/A B 2 Locator Tone? | N/A | | | | |
| N/A B 1 Percussive Walk Cycle? | No | N/A B 2 Percussive Walk Cycle? | N/A | | | | |
| N/A B 1 Extended Press Feature? | No | N/A B 2 Extended Press Feature? | N/A | | | | |
| N/A B 1 Tone Audible Range? | No | N/A B 2 Tone Audible Range? | N/A | | | | |

| | | | | Possible Solutions: Replace Signal Push Button With APS Button on New Post. Remove & Relocate Sign. | | | |
