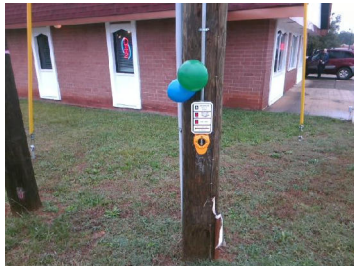
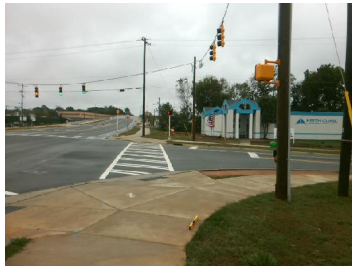
Is Button 1 APS or Non-APS?	APS	Is Button 2 APS or Non-APS?	N/A
Yes B 1 VibroTact Arrow?	Yes	N/A B 2 VibroTact Arrow?	N/A
No B 1 VibroTact Parallel to Xing?	No	N/A B 2 VibroTact Parallel to Xing?	N/A
Yes B 1 VibroTact Contrast	Yes	N/A B 2 VibroTact Contrast	N/A
Yes B 1 Pilot Light?	Yes	N/A B 2 Pilot Light?	N/A
Yes B 1 Pilot Light Illumination?	Yes	N/A B 2 Pilot Light Illumination?	N/A
No B 1 Verbal Walk Cycle?	Yes	N/A B 2 Verbal Walk Cycle?	N/A
N/A B 1 Verbal Message Audible?	Yes	N/A B 2 Verbal Message Audible?	N/A
Yes B 1 Locator Tone?	Yes	N/A B 2 Locator Tone?	N/A
Yes B 1 Percussive Walk Cycle?	Yes	N/A B 2 Percussive Walk Cycle?	N/A
Yes B 1 Extended Press Feature?	Yes	N/A B 2 Extended Press Feature?	N/A
Yes B 1 Tone Audible Range?	Yes	N/A B 2 Tone Audible Range?	N/A

No B 1 Clear Xing Direction?	NotClearlyMarked	N/A B 2 Clear Xing Direction?	N/A
B 1 Crossing Direction	To S	B 2 Crossing Direction	N/A
Yes B 1 DistanceTo XWalk (in)	48.0	N/A B 2 DistanceTo XWalk (in)	N/A
No B 1 DistanceTo Curb (in)	197.0	N/A B 2 DistanceTo Curb (in)	N/A
Yes B 1 Diameter (in)	2.0	N/A B 2 Diameter (in)	N/A

Possible Solutions: Replace Signal Push Button With APS Button on New Post.
