## **Access Compliance Report Public Rights-of-Way** (Pedestrian Signals)

Intersection ID: N/A **Main Street:** Cross Street: N/A Location: N/A

Severity Score: BTN 1:N/A BTN 2: N/A No BTN: Signal Type: One Push Button-Non APS ADA ID: 590363A17A86 **Overall Compliance: No** N/A

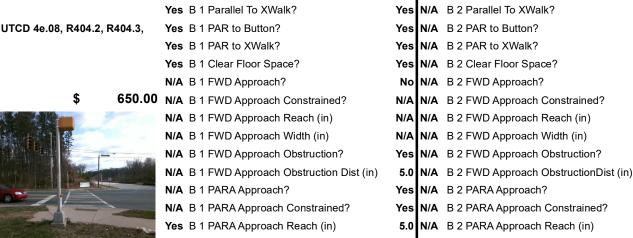
132.0 N/A B 2 DistanceTo Curb (in)

Possible Solutions: Replace Signal Push Button With APS Button on New Post. Remove & Relocate Sign.

PROW/ADA: TMUTCD 4e.08, R404.2, R404.3, R404.7.2
