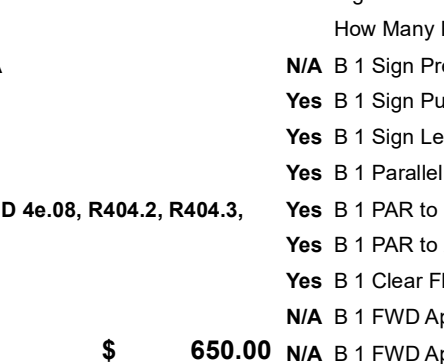
APS Compliance		MUTCD Compliance	
Is Button 1 APS or Non-APS?	NonAPS	Is Button 2 APS or Non-APS?	N/A
N/A B 1 VibroTact Arrow?	No	N/A B 2 VibroTact Arrow?	N/A
N/A B 1 VibroTact Parallel to Xing?	No	N/A B 2 VibroTact Parallel to Xing?	N/A
N/A B 1 VibroTact Contrast	No	N/A B 2 VibroTact Contrast	N/A
N/A B 1 Pilot Light?	No	N/A B 2 Pilot Light?	N/A
N/A B 1 Pilot Light Illumination?	No	N/A B 2 Pilot Light Illumination?	N/A
N/A B 1 Verbal Walk Cycle?	No	N/A B 2 Verbal Walk Cycle?	N/A
N/A B 1 Verbal Message Audible?	No	N/A B 2 Verbal Message Audible?	N/A
N/A B 1 Locator Tone?	No	N/A B 2 Locator Tone?	N/A
N/A B 1 Percussive Walk Cycle?	No	N/A B 2 Percussive Walk Cycle?	N/A
N/A B 1 Extended Press Feature?	No	N/A B 2 Extended Press Feature?	N/A

N/A B 1 Tone Audible Range?	No	N/A B 2 Tone Audible Range?	N/A
MUTCD Compliance		MUTCD Compliance	
Yes B 1 Clear Xing Direction?	ClearlyMarked	N/A B 2 Clear Xing Direction?	N/A
B 1 Crossing Direction	To NW	B 2 Crossing Direction	N/A
Yes B 1 DistanceTo XWalk (in)	15.0	N/A B 2 DistanceTo XWalk (in)	N/A
No B 1 DistanceTo Curb (in)	77.0	N/A B 2 DistanceTo Curb (in)	N/A
Yes B 1 Diameter (in)	2.0	N/A B 2 Diameter (in)	N/A

Possible Solutions: Replace Signal Push Button With APS Button on New Post. Remove & Relocate Sign.	
		Surveyor Notes: N/A	
		PROW/ADA: TMUTCD 4e.08, R404.2, R404.3, R404.7.3	
		Total Cost: \$ 650.00
