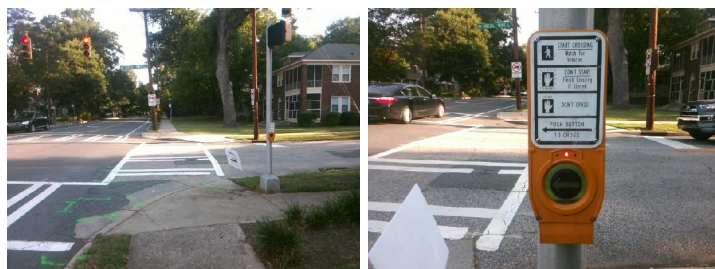
Surveyor Notes: TEXT SPACE HT IS 1/4

PROW/ADA: R410.6, TMUTCD 4e.08, R404.2, R406.2, R209.1, MUTCD 4e.10,

APS Compliance			
Is Button 1 APS or Non-APS?	APS	Is Button 2 APS or Non-APS?	N/A
Yes B 1 VibroTact Arrow?	Yes	N/A B 2 VibroTact Arrow?	N/A
Yes B 1 VibroTact Parallel to Xing?	Yes	N/A B 2 VibroTact Parallel to Xing?	N/A
Yes B 1 VibroTact Contrast	Yes	N/A B 2 VibroTact Contrast	N/A
Yes B 1 Pilot Light?	Yes	N/A B 2 Pilot Light?	N/A
Yes B 1 Pilot Light Illumination?	Yes	N/A B 2 Pilot Light Illumination?	N/A
No B 1 Verbal Walk Cycle?	Yes	N/A B 2 Verbal Walk Cycle?	N/A
N/A B 1 Verbal Message Audible?	Yes	N/A B 2 Verbal Message Audible?	N/A
Yes B 1 Locator Tone?	Yes	N/A B 2 Locator Tone?	N/A
No B 1 Percussive Walk Cycle?	No	N/A B 2 Percussive Walk Cycle?	N/A
Yes B 1 Extended Press Feature?	Yes	N/A B 2 Extended Press Feature?	N/A
Yes B 1 Tone Audible Range?	Yes	N/A B 2 Tone Audible Range?	N/A

MUTCD Compliance			
Yes B 1 Clear Xing Direction?	ClearlyMarked	N/A B 2 Clear Xing Direction?	N/A
B 1 Crossing Direction	To W	B 2 Crossing Direction	N/A
Yes B 1 DistanceTo XWalk (in)	0.0	N/A B 2 DistanceTo XWalk (in)	N/A
No B 1 DistanceTo Curb (in)	105.0	N/A B 2 DistanceTo Curb (in)	N/A
Yes B 1 Diameter (in)	2.0	N/A B 2 Diameter (in)	N/A

Possible Solutions: Replace Signal Push Button With APS Button on New Post. Remove & Replace Sign.

Total Cost: \$ 700.00
