Access Compliance Report Public Rights-of-Way (Pedestrian Signals)

Intersection ID: N/A **Main Street:** Cross Street: N/A Location: N/A

Signal Type: One Push Button-Non APS Severity Score: BTN 1:N/A BTN 2: N/A No BTN: N/A ADA ID: E3C6CE5A6338 **Overall Compliance: No**

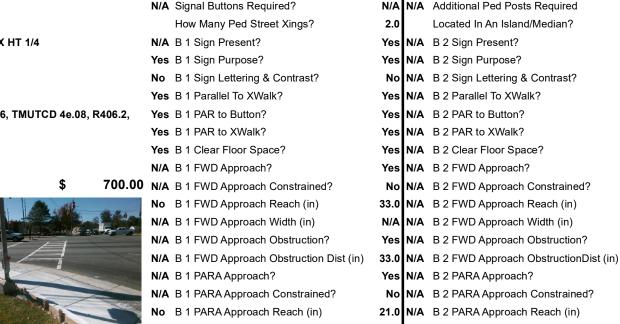
Surveyor Notes: TX HT 1/4

N/A B 1 PARA Approach Width (in)	N/A	N/A	B 2 PARA Approach Width (in)	N/A
				N/A B 1 PARA Approach Obstruction	? Yes	N/A	B 2 PARA Approach Obstruction?	N/A
APS Compliance			N/A B 1 PARA Approach Obstruction	Dist (in) 21.0	N/A	B 2 PARA Approach ObstructionDist (in)) N/A	
Is Button 1 APS or Non-APS?	NonAPS	Is Button 2 APS or Non-APS?	N/A	Yes B 1 Clear Floor Space Slope (%) 1.8	N/A	B 2 Clear Floor Space Slope (%)	N/A
N/A B 1 VibroTact Arrow?	N/A N/	/A B 2 VibroTact Arrow?	N/A	Yes B 1 Clear Floor Space XSlope (9	%) 1.1	N/A	B 2 Clear Floor Space XSlope (%)	N/A
N/A B 1 VibroTact Parallel to Xing?	N/A N/	/A B 2 VibroTact Parallel to Xing?	N/A	N/A B 1 PAR Slope (%)	7.2	N/A	B 2 PAR Slope (%)	N/A
N/A B 1 VibroTact Contrast	N/A N/	/A B 2 VibroTact Contrast	N/A	Yes B 1 Height (in)	40.0	N/A	B 2 Height (in)	N/A
N/A B 1 Pilot Light?	N/A N/	/A B 2 Pilot Light?	N/A	Yes B 1 Pressure (#)	2.0	N/A	B 2 Pressure (#)	N/A

N/A B 1 Pilot Light Illumination?	N/A N/	/A B 2 Pilot Light Illumination?	N/A	Yes B 1 Closed Fist Operation?	Yes	N/A	B 2 Closed Fist Operation?	N/A
N/A B 1 Verbal Walk Cycle?	N/A N/	/A B 2 Verbal Walk Cycle?	N/A	MUTCD Compliance				
N/A B 1 Verbal Message Audible?	N/A N/	/A B 2 Verbal Message Audible?	N/A	Yes B 1 Clear Xing Direction?	ClearlyMarked	N/A	B 2 Clear Xing Direction?	N/A
N/A B 1 Locator Tone?	N/A N/	/A B 2 Locator Tone?	N/A	B 1 Crossing Direction	To SW		B 2 Crossing Direction	N/A
N/A B 1 Percussive Walk Cycle?	N/A N/	/A B 2 Percussive Walk Cycle?	N/A	Yes B 1 DistanceTo XWalk (in)	0.0	N/A	B 2 DistanceTo XWalk (in)	N/A
N/A B 1 Extended Press Feature?	N/A N/	A B 2 Extended Press Feature?	N/A	No B 1 DistanceTo Curb (in)	130.0	N/A	B 2 DistanceTo Curb (in)	N/A

Possible Solutions: Replace Signal Push Button With APS Button on New Post. Remove & Replace Sign.

PROW/ADA: R410.6, TMUTCD 4e.08, R406.2, R404.7.3
