# Access Compliance Report

## Public Rights-of-Way

### (Island Curb Cuts)

| Intersection ID: 23966 | Main Street: CAROLINA_PAVILION_DR_N | Cross Street: SOUTH_BV | Location: S |

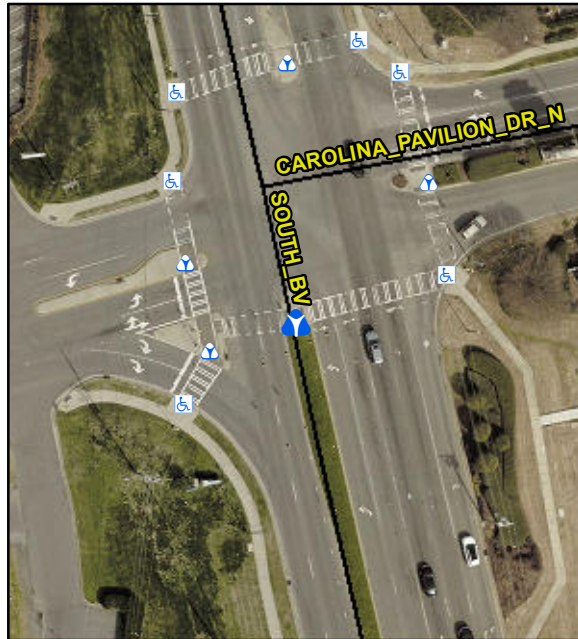
| ADA ID: 03454DCE427A | Curb Cut Type: MedianRefuge2 | Initial Pass/Fail: Fail | Overall Compliance: No |
| Severity Score: 1.25 | | | |

| Compliance | Description | Data | Compliance | Description | Data |
|---|---|---|---|---|---|
| Yes | Any Obstructions? | N/A | N/A | Storm Grate/Utility Hazard? | N/A |

**Remove & Replace Entire Refuge.**

Total Cost: \$ 3000.00

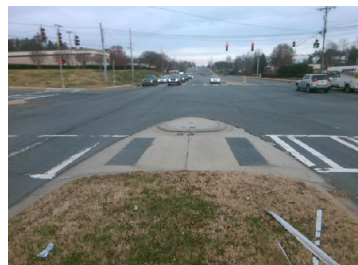
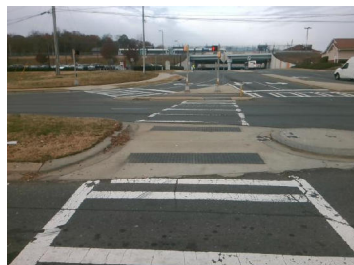
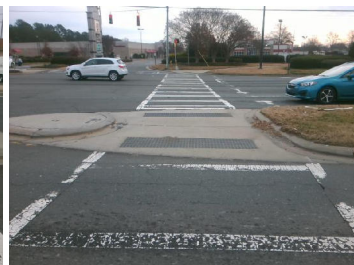
| Compliance | Description | Data | Compliance | Description | Data |
|---|---|---|---|---|---|
| N/A | Surface Condition | Good | | | |
