Access Compliance Report

Public Rights-of-Way

(Island Curb Cuts)

Intersection ID: 3180	Main Street: JOHNSTON_OEHLER_RD	Cross Street: SONG_SPARROW_LN	Location: SE
ADA ID: 090F1F8D4F0A	Curb Cut Type: MedianRefuge2	Initial Pass/Fail: Fail	Overall Compliance: No
Codes/Mitigation Info/Possible Solution		Field Measurements/Component Compliance	
Severity Score: 25

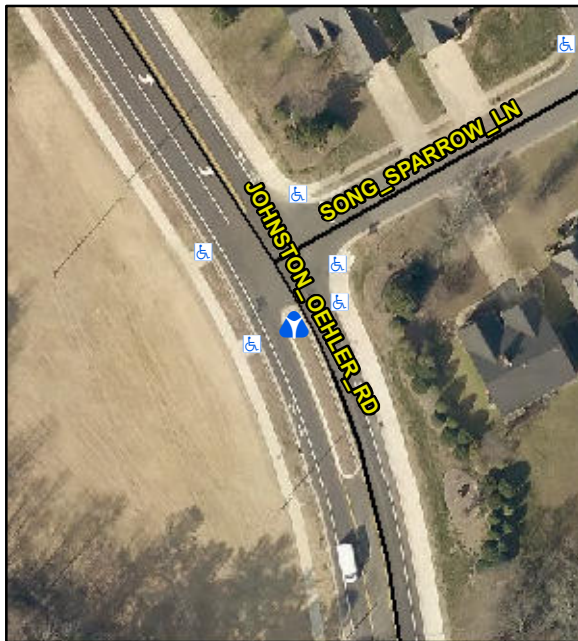
Compliance	Description	Data	Compliance	Description	Data
Yes	Refuge 1 Length (In)	48.0	N/A	Gutter 1 Ponding?	N/A
Yes	Refuge 1 Width (In)	95.0	N/A	Gutter 1 Lip Ht (In)	N/A
No	Refuge 1 Slope (%)	7.7	N/A	Gutter 1 Slope (%)	N/A
Yes	Refuge 1 X Slope (%)	1.1	N/A	Gutter 1 X Slope (%)	N/A
N/A	Painted X Walk1?	No	N/A	DWS 1 Provided?	N/A
N/A	X Walk 1 Direction	To NE	N/A	DWS 1 Contrast?	N/A
N/A	X Walk 1 Width (In)	N/A	N/A	DWS 1 Length (In)	N/A
N/A	Road 1 Slope (%)	1.9	N/A	DWS 1 Full Width?	N/A
N/A	Road 1 X Slope (%)	2.7	N/A	DWS 1 Offset (In)	N/A
Yes	Refuge 2 Length (In)	48.0	N/A	Gutter 2 Ponding?	N/A
Yes	Refuge 2 Width (In)	95.0	N/A	Gutter 2 Lip Ht (In)	N/A
No	Refuge 2 Slope (%)	9.0	N/A	Gutter 2 Slope (%)	N/A
Yes	Refuge 2 X Slope (%)	1.6	N/A	Gutter 2 X Slope (%)	N/A
N/A	Painted X Walk2?	No	N/A	DWS 2 Provided?	N/A
N/A	X Walk 2 Direction	To SW	N/A	DWS 2 Contrast?	N/A
N/A	X Walk 2 Width (In)	N/A	N/A	DWS 2 Length (In)	N/A

Possible Solutions:

Remove & Replace Entire Refuge.

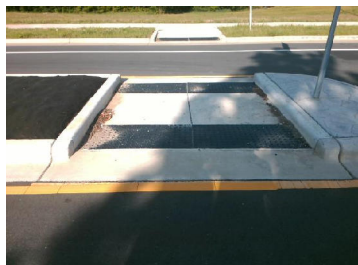
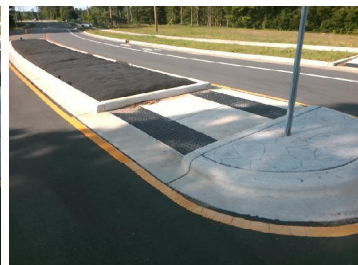
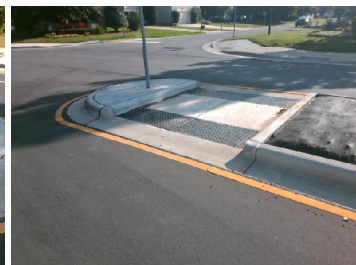
N/A	Road 2 Slope (%)	1.3	N/A	DWS 2 Full Width?	N/A
N/A	Road 2 X Slope (%)	2.8	N/A	DWS 2 Offset (In)	N/A
N/A	Refuge 3 Length (in)	N/A	N/A	Gutter 3 Ponding?	N/A
N/A	Refuge 3 Width (in)	N/A	N/A	Gutter 3 Lip Ht (in)	N/A
N/A	Refuge 3 Slope (%)	N/A	N/A	Gutter 3 Slope (%)	N/A
N/A	Refuge 3 XSlope (%)	N/A	N/A	Gutter 3 XSlope (%)	N/A
N/A	Painted X Walk3?	No	N/A	DWS 3 Provided?	N/A
N/A	X Walk 3 Direction	N/A	N/A	DWS 3 Contrast?	N/A
N/A	X Walk 3 Width (in)	N/A	N/A	DWS 3 Length (in)	N/A
N/A	Road 3 Slope (%)	N/A	N/A	DWS 3 Full Width?	N/A
N/A	Road 3 XSlope (%)	N/A	N/A	DWS 3 Offset (in)	N/A
Yes	Any Obstructions?	N/A	N/A	Storm Grate/Utility Hazard?	N/A
N/A	Obstruction Type		N/A	Storm Grate/Utility Type	
		N/A			N/A
N/A	Surface Condition	Good
