Access Compliance Report

Public Rights-of-Way

(Island Curb Cuts)

Intersection ID: 27333	Main Street: BALLANTYNE_MEDICAL_PL	Cross Street: BRIXHAM_HILL_AV	Location: NW
ADA ID: 0A5A1182EC42	Curb Cut Type: MedianRefuge2	Initial Pass/Fail: Fail	Overall Compliance: No
Severity Score: 1.25			
Codes/Mitigation Info/Possible Solution		Field Measurements/Component Compliance

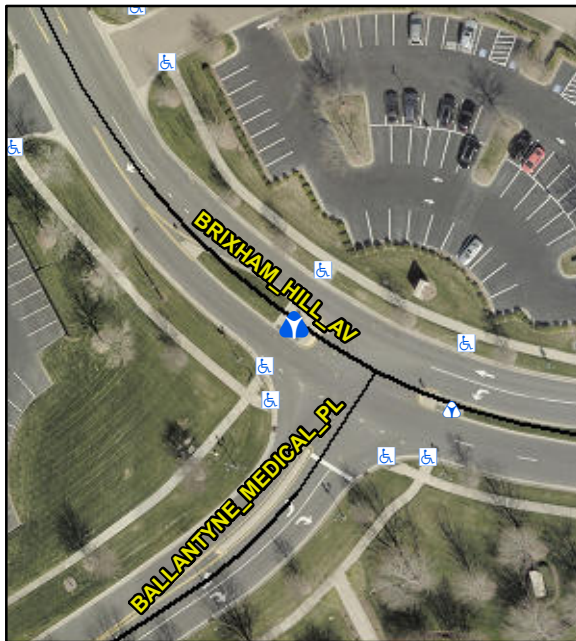
Compliance	Description	Data	Compliance	Description	Data
Yes	Refuge 1 Length (In)	106.5	N/A	Gutter 1 Ponding?	N/A
Yes	Refuge 1 Width (In)	169.0	N/A	Gutter 1 Lip Ht (In)	N/A
Yes	Refuge 1 Slope (%)	2.6	N/A	Gutter 1 Slope (%)	N/A
Yes	Refuge 1 X Slope (%)	3.0	N/A	Gutter 1 X Slope (%)	N/A
N/A	Painted X Walk1?	No	N/A	DWS 1 Provided?	N/A
N/A	X Walk 1 Direction	To NE	N/A	DWS 1 Contrast?	N/A
N/A	X Walk 1 Width (In)	N/A	N/A	DWS 1 Length (In)	N/A
N/A	Road 1 Slope (%)	0.4	N/A	DWS 1 Full Width?	N/A
N/A	Road 1 X Slope (%)	5.6	N/A	DWS 1 Offset (In)	N/A
Yes	Refuge 2 Length (In)	106.5	N/A	Gutter 2 Ponding?	N/A
Yes	Refuge 2 Width (In)	169.0	N/A	Gutter 2 Lip Ht (In)	N/A
Yes	Refuge 2 Slope (%)	3.1	N/A	Gutter 2 Slope (%)	N/A
Yes	Refuge 2 X Slope (%)	1.2	N/A	Gutter 2 X Slope (%)	N/A
N/A	Painted X Walk2?	No	N/A	DWS 2 Provided?	N/A
N/A	X Walk 2 Direction	To SW	N/A	DWS 2 Contrast?	N/A
N/A	X Walk 2 Width (In)	N/A	N/A	DWS 2 Length (In)	N/A

N/A	Road 2 Slope (%)	2.4	N/A	DWS 2 Full Width?	N/A
N/A	Road 2 X Slope (%)	0.5	N/A	DWS 2 Offset (In)	N/A
N/A	Refuge 3 Length (in)	N/A	N/A	Gutter 3 Ponding?	N/A
N/A	Refuge 3 Width (in)	N/A	N/A	Gutter 3 Lip Ht (in)	N/A
N/A	Refuge 3 Slope (%)	N/A	N/A	Gutter 3 Slope (%)	N/A
N/A	Refuge 3 XSlope (%)	N/A	N/A	Gutter 3 XSlope (%)	N/A
N/A	Painted X Walk3?	N/A	N/A	DWS 3 Provided?	N/A
N/A	X Walk 3 Direction	N/A	N/A	DWS 3 Contrast?	N/A
N/A	X Walk 3 Width (in)	N/A	N/A	DWS 3 Length (in)	N/A
N/A	Road 3 Slope (%)	N/A	N/A	DWS 3 Full Width?	N/A
N/A	Road 3 XSlope (%)	N/A	N/A	DWS 3 Offset (in)	N/A
Yes	Any Obstructions?	N/A	N/A	Storm Grate/Utility Hazard?	N/A
N/A	Obstruction Type		N/A	Storm Grate/Utility Type	
			N/A		N/A
N/A	Surface Condition	Good

Possible Solutions:

Remove & Replace Entire Refuge.
