# Access Compliance Report

## Public Rights-of-Way

### (Island Curb Cuts)

Intersection ID: 8193	Main Street: E_W_T_HARRIS_BV	Cross Street: GRIER_RD	Location: S
ADA ID: 0EBC34A8CEC2	Curb Cut Type: MedianRefuge2	Initial Pass/Fail: Fail	Overall Compliance: No
Severity Score: 0			
Codes/Mitigation Info/Possible Solution		Field Measurements/Component Compliance

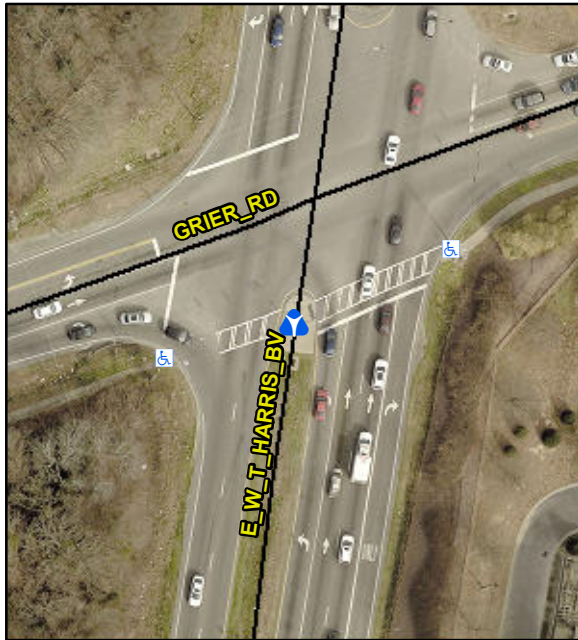
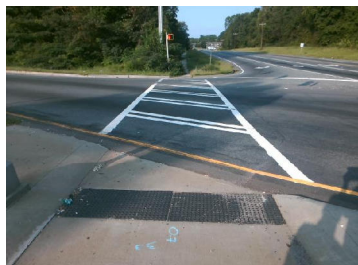
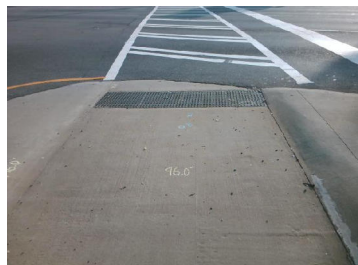
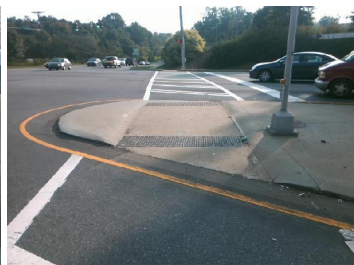
Compliance	Description	Data	Compliance	Description	Data
Yes	Refuge 1 Length (In)	98.0	N/A	Gutter 1 Ponding?	N/A
Yes	Refuge 1 Width (In)	96.0	N/A	Gutter 1 Lip Ht (In)	N/A
Yes	Refuge 1 Slope (%)	0.7	N/A	Gutter 1 Slope (%)	N/A
Yes	Refuge 1 X Slope (%)	3.3	N/A	Gutter 1 X Slope (%)	N/A
N/A	Painted X Walk1?	Yes	N/A	DWS 1 Provided?	N/A
N/A	X Walk 1 Direction	To W	N/A	DWS 1 Contrast?	N/A
N/A	X Walk 1 Width (In)	142.0	N/A	DWS 1 Length (In)	N/A
N/A	Road 1 Slope (%)	2.6	N/A	DWS 1 Full Width?	N/A
N/A	Road 1 X Slope (%)	0.6	N/A	DWS 1 Offset (In)	N/A
Yes	Refuge 2 Length (In)	98.0	N/A	Gutter 2 Ponding?	N/A
Yes	Refuge 2 Width (In)	96.0	N/A	Gutter 2 Lip Ht (In)	N/A
Yes	Refuge 2 Slope (%)	1.2	N/A	Gutter 2 Slope (%)	N/A
Yes	Refuge 2 X Slope (%)	2.0	N/A	Gutter 2 X Slope (%)	N/A
N/A	Painted X Walk2?	Yes	N/A	DWS 2 Provided?	N/A
N/A	X Walk 2 Direction	To E	N/A	DWS 2 Contrast?	N/A
N/A	X Walk 2 Width (In)	125.5	N/A	DWS 2 Length (In)	N/A

N/A	Road 2 Slope (%)	2.1	N/A	DWS 2 Full Width?	N/A
N/A	Road 2 X Slope (%)	1.7	N/A	DWS 2 Offset (In)	N/A
N/A	Refuge 3 Length (in)	N/A	N/A	Gutter 3 Ponding?	N/A
N/A	Refuge 3 Width (in)	N/A	N/A	Gutter 3 Lip Ht (in)	N/A
N/A	Refuge 3 Slope (%)	N/A	N/A	Gutter 3 Slope (%)	N/A
N/A	Refuge 3 XSlope (%)	N/A	N/A	Gutter 3 XSlope (%)	N/A
N/A	Painted X Walk3?	No	N/A	DWS 3 Provided?	N/A
N/A	X Walk 3 Direction	N/A	N/A	DWS 3 Contrast?	N/A
N/A	X Walk 3 Width (in)	N/A	N/A	DWS 3 Length (in)	N/A
N/A	Road 3 Slope (%)	N/A	N/A	DWS 3 Full Width?	N/A
N/A	Road 3 XSlope (%)	N/A	N/A	DWS 3 Offset (in)	N/A
Yes	Any Obstructions?	N/A	N/A	Storm Grate/Utility Hazard?	N/A
N/A	Obstruction Type		N/A	Storm Grate/Utility Type	
		N/A			N/A
N/A	Surface Condition	Good

**Remove & Replace Entire Refuge.**

Total Cost: \$ 3000.00
