Access Compliance Report

Public Rights-of-Way

(Island Curb Cuts)

Intersection ID: 10630	Main Street: E_SUGAR_CREEK_RD	Cross Street: EASTWAY_DR	Location: SE
ADA ID: 14BD04ECE95E	Curb Cut Type: MedianRefuge2	Initial Pass/Fail: Fail	Overall Compliance: No
Severity Score: 0			
Codes/Mitigation Info/Possible Solution		Field Measurements/Component Compliance

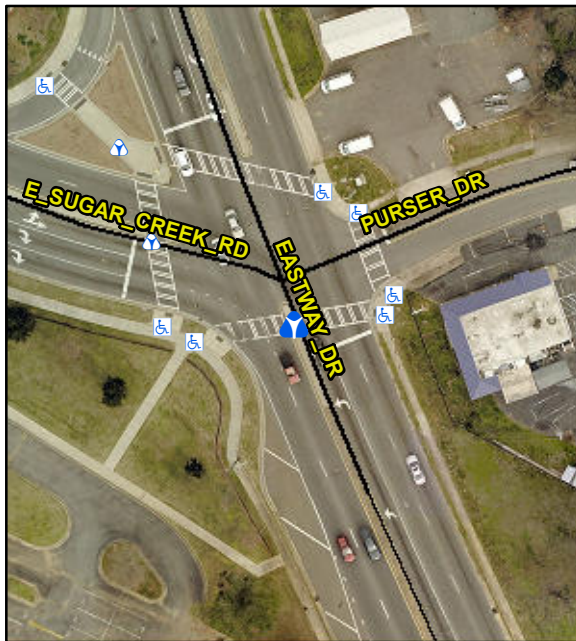
Compliance	Description	Data	Compliance	Description	Data
No	Refuge 1 Length (In)	24.75	N/A	Gutter 1 Ponding?	N/A
Yes	Refuge 1 Width (In)	97.5	N/A	Gutter 1 Lip Ht (In)	N/A
Yes	Refuge 1 Slope (%)	1.4	N/A	Gutter 1 Slope (%)	N/A
Yes	Refuge 1 X Slope (%)	3.7	N/A	Gutter 1 X Slope (%)	N/A
N/A	Painted X Walk1?	Yes	N/A	DWS 1 Provided?	N/A
N/A	X Walk 1 Direction	To W	N/A	DWS 1 Contrast?	N/A
N/A	X Walk 1 Width (In)	113.5	N/A	DWS 1 Length (In)	N/A
N/A	Road 1 Slope (%)	3.5	N/A	DWS 1 Full Width?	N/A
N/A	Road 1 X Slope (%)	0.5	N/A	DWS 1 Offset (In)	N/A
No	Refuge 2 Length (In)	24.75	N/A	Gutter 2 Ponding?	N/A
Yes	Refuge 2 Width (In)	97.5	N/A	Gutter 2 Lip Ht (In)	N/A
Yes	Refuge 2 Slope (%)	2.0	N/A	Gutter 2 Slope (%)	N/A
Yes	Refuge 2 X Slope (%)	3.3	N/A	Gutter 2 X Slope (%)	N/A
N/A	Painted X Walk2?	Yes	N/A	DWS 2 Provided?	N/A
N/A	X Walk 2 Direction	To E	N/A	DWS 2 Contrast?	N/A
N/A	X Walk 2 Width (In)	111.5	N/A	DWS 2 Length (In)	N/A

N/A	Road 2 Slope (%)	3.6	N/A	DWS 2 Full Width?	N/A
N/A	Road 2 X Slope (%)	0.8	N/A	DWS 2 Offset (In)	N/A
N/A	Refuge 3 Length (in)	N/A	N/A	Gutter 3 Ponding?	N/A
N/A	Refuge 3 Width (in)	N/A	N/A	Gutter 3 Lip Ht (in)	N/A
N/A	Refuge 3 Slope (%)	N/A	N/A	Gutter 3 Slope (%)	N/A
N/A	Refuge 3 XSlope (%)	N/A	N/A	Gutter 3 XSlope (%)	N/A
N/A	Painted X Walk3?	N/A	N/A	DWS 3 Provided?	N/A
N/A	X Walk 3 Direction	N/A	N/A	DWS 3 Contrast?	N/A
N/A	X Walk 3 Width (in)	N/A	N/A	DWS 3 Length (in)	N/A
N/A	Road 3 Slope (%)	N/A	N/A	DWS 3 Full Width?	N/A
N/A	Road 3 XSlope (%)	N/A	N/A	DWS 3 Offset (in)	N/A
Yes	Any Obstructions?	N/A	N/A	Storm Grate/Utility Hazard?	N/A
N/A	Obstruction Type		N/A	Storm Grate/Utility Type	
		N/A			N/A
N/A	Surface Condition	Good

Remove & Replace Entire Refuge.
