# Access Compliance Report

## Public Rights-of-Way

### (Island Curb Cuts)

Intersection ID: 19242	Main Street: SHARON_LN	Cross Street: SHARON_RD	Location: NE
ADA ID: 1765A85A8C7D	Curb Cut Type: IslandRefuge3	Initial Pass/Fail: Fail	Overall Compliance: No
Codes/Mitigation Info/Possible Solution		Field Measurements/Component Compliance

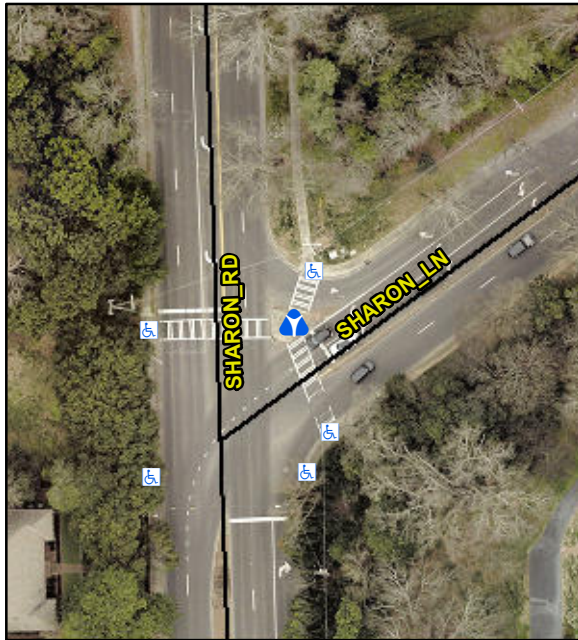
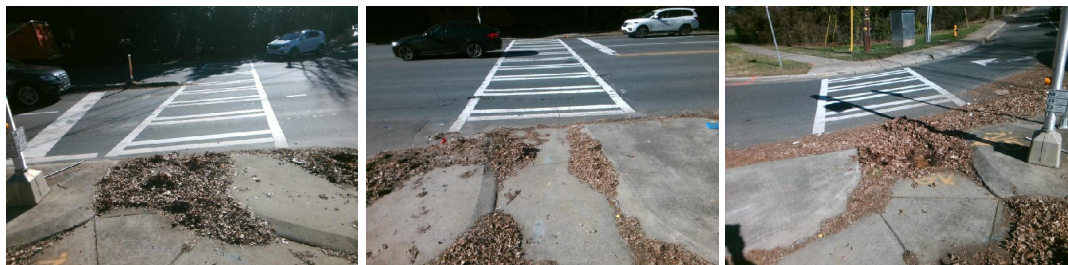
Compliance	Description	Data	Compliance	Description	Data
Yes	Refuge 1 Length (In)	58.0	N/A	Gutter 1 Ponding?	N/A
No	Refuge 1 Width (In)	51.0	N/A	Gutter 1 Lip Ht (In)	N/A
Yes	Refuge 1 Slope (%)	1.7	N/A	Gutter 1 Slope (%)	N/A
Yes	Refuge 1 X Slope (%)	1.7	N/A	Gutter 1 X Slope (%)	N/A
N/A	Painted X Walk1?	Yes	N/A	DWS 1 Provided?	N/A
N/A	X Walk 1 Direction	To SE	N/A	DWS 1 Contrast?	N/A
N/A	X Walk 1 Width (In)	108.0	N/A	DWS 1 Length (In)	N/A
N/A	Road 1 Slope (%)	0.7	N/A	DWS 1 Full Width?	N/A
N/A	Road 1 X Slope (%)	0.8	N/A	DWS 1 Offset (In)	N/A
Yes	Refuge 2 Length (In)	113.0	N/A	Gutter 2 Ponding?	N/A
No	Refuge 2 Width (In)	48.0	N/A	Gutter 2 Lip Ht (In)	N/A
Yes	Refuge 2 Slope (%)	2.9	N/A	Gutter 2 Slope (%)	N/A
Yes	Refuge 2 X Slope (%)	2.6	N/A	Gutter 2 X Slope (%)	N/A
N/A	Painted X Walk2?	Yes	N/A	DWS 2 Provided?	N/A
N/A	X Walk 2 Direction	To W	N/A	DWS 2 Contrast?	N/A
N/A	X Walk 2 Width (In)	120.0	N/A	DWS 2 Length (In)	N/A

N/A	Road 2 Slope (%)	1.2	N/A	DWS 2 Full Width?	N/A
N/A	Road 2 X Slope (%)	2.9	N/A	DWS 2 Offset (In)	N/A
Yes	Refuge 3 Length (in)	55.0	N/A	Gutter 3 Ponding?	N/A
No	Refuge 3 Width (in)	53.0	N/A	Gutter 3 Lip Ht (in)	N/A
Yes	Refuge 3 Slope (%)	3.8	N/A	Gutter 3 Slope (%)	N/A
Yes	Refuge 3 XSlope (%)	2.5	N/A	Gutter 3 XSlope (%)	N/A
N/A	Painted X Walk3?	Yes	N/A	DWS 3 Provided?	N/A
N/A	X Walk 3 Direction	To NE	N/A	DWS 3 Contrast?	N/A
N/A	X Walk 3 Width (in)	109.0	N/A	DWS 3 Length (in)	N/A
N/A	Road 3 Slope (%)	2.8	N/A	DWS 3 Full Width?	N/A
N/A	Road 3 XSlope (%)	0.4	N/A	DWS 3 Offset (in)	N/A
Yes	Any Obstructions?	N/A	N/A	Storm Grate/Utility Hazard?	N/A
N/A	Obstruction Type		N/A	Storm Grate/Utility Type	
			N/A		N/A
N/A	Surface Condition	Good

**Remove & Replace Entire Refuge.**

Total Cost: \$ 3000.00
