# Access Compliance Report

## Public Rights-of-Way

### (Island Curb Cuts)

Intersection ID: 52100	Main Street: FRED_D_ALEXANDER_BV	Cross Street: FREEDOM_DR	Location: NE
ADA ID: 18C563A4E82A	Curb Cut Type: MedianRefuge2	Initial Pass/Fail: Fail	Overall Compliance: No
Severity Score: 1.25			
Codes/Mitigation Info/Possible Solution		Field Measurements/Component Compliance

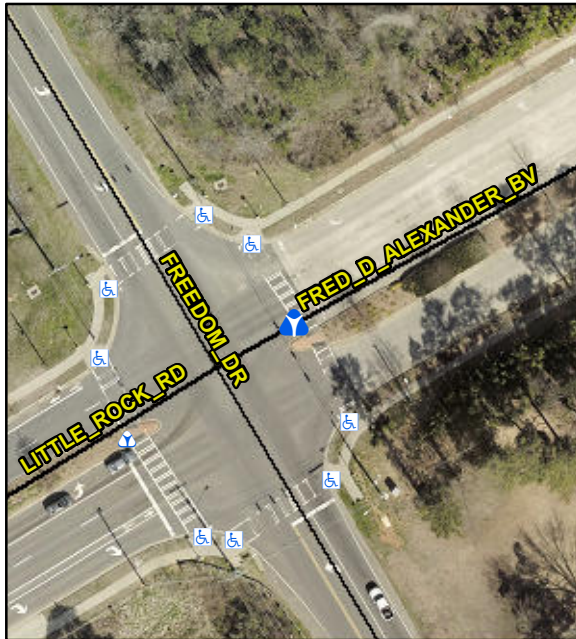
Compliance	Description	Data	Compliance	Description	Data
Yes	Refuge 1 Length (In)	46.5	N/A	Gutter 1 Ponding?	N/A
Yes	Refuge 1 Width (In)	92.0	N/A	Gutter 1 Lip Ht (In)	N/A
Yes	Refuge 1 Slope (%)	0.4	N/A	Gutter 1 Slope (%)	N/A
Yes	Refuge 1 X Slope (%)	1.7	N/A	Gutter 1 X Slope (%)	N/A
N/A	Painted X Walk1?	Yes	N/A	DWS 1 Provided?	N/A
N/A	X Walk 1 Direction	To NE	N/A	DWS 1 Contrast?	N/A
N/A	X Walk 1 Width (In)	89.0	N/A	DWS 1 Length (In)	N/A
N/A	Road 1 Slope (%)	2.2	N/A	DWS 1 Full Width?	N/A
N/A	Road 1 X Slope (%)	0.1	N/A	DWS 1 Offset (In)	N/A
Yes	Refuge 2 Length (In)	46.5	N/A	Gutter 2 Ponding?	N/A
Yes	Refuge 2 Width (In)	92.0	N/A	Gutter 2 Lip Ht (In)	N/A
Yes	Refuge 2 Slope (%)	2.5	N/A	Gutter 2 Slope (%)	N/A
Yes	Refuge 2 X Slope (%)	2.4	N/A	Gutter 2 X Slope (%)	N/A
N/A	Painted X Walk2?	Yes	N/A	DWS 2 Provided?	N/A
N/A	X Walk 2 Direction	To SE	N/A	DWS 2 Contrast?	N/A
N/A	X Walk 2 Width (In)	87.0	N/A	DWS 2 Length (In)	N/A

N/A	Road 2 Slope (%)	3.0	N/A	DWS 2 Full Width?	N/A
N/A	Road 2 X Slope (%)	1.4	N/A	DWS 2 Offset (In)	N/A
N/A	Refuge 3 Length (in)	N/A	N/A	Gutter 3 Ponding?	N/A
N/A	Refuge 3 Width (in)	N/A	N/A	Gutter 3 Lip Ht (in)	N/A
N/A	Refuge 3 Slope (%)	N/A	N/A	Gutter 3 Slope (%)	N/A
N/A	Refuge 3 XSlope (%)	N/A	N/A	Gutter 3 XSlope (%)	N/A
N/A	Painted X Walk3?	N/A	N/A	DWS 3 Provided?	N/A
N/A	X Walk 3 Direction	N/A	N/A	DWS 3 Contrast?	N/A
N/A	X Walk 3 Width (in)	N/A	N/A	DWS 3 Length (in)	N/A
N/A	Road 3 Slope (%)	N/A	N/A	DWS 3 Full Width?	N/A
N/A	Road 3 XSlope (%)	N/A	N/A	DWS 3 Offset (in)	N/A
Yes	Any Obstructions?	N/A	N/A	Storm Grate/Utility Hazard?	N/A
N/A	Obstruction Type		N/A	Storm Grate/Utility Type	
		N/A			N/A
N/A	Surface Condition	Good

Possible Solutions:

**Remove & Replace Entire Refuge.**

**\$ 3000.00**
