# Access Compliance Report

## Public Rights-of-Way

### (Island Curb Cuts)

Intersection ID: 5714	Main Street: JOHN_KIRK_DR	Cross Street: UNIVERSITY_CITY_BV	Location: E
ADA ID: 1905AD3E26CD	Curb Cut Type: MedianRefuge2	Initial Pass/Fail: Fail	Overall Compliance: No
Codes/Mitigation Info/Possible Solution		Field Measurements/Component Compliance	
Severity Score: 25

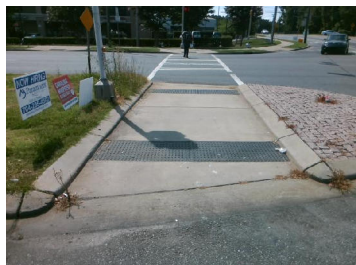
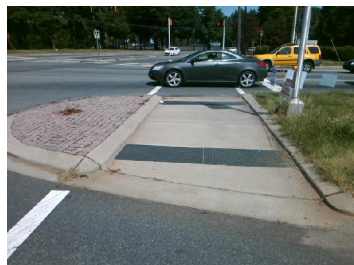
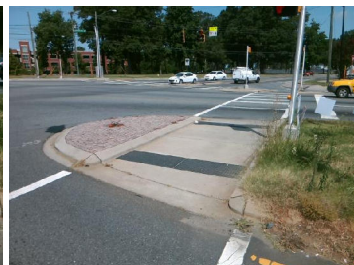
Compliance	Description	Data	Compliance	Description	Data
Yes	Refuge 1 Length (In)	111.5	N/A	Gutter 1 Ponding?	N/A
Yes	Refuge 1 Width (In)	96.0	N/A	Gutter 1 Lip Ht (In)	N/A
Yes	Refuge 1 Slope (%)	4.8	N/A	Gutter 1 Slope (%)	N/A
Yes	Refuge 1 X Slope (%)	1.5	N/A	Gutter 1 X Slope (%)	N/A
N/A	Painted X Walk1?	Yes	N/A	DWS 1 Provided?	N/A
N/A	X Walk 1 Direction	To NW	N/A	DWS 1 Contrast?	N/A
N/A	X Walk 1 Width (In)	114.1	N/A	DWS 1 Length (In)	N/A
N/A	Road 1 Slope (%)	2.5	N/A	DWS 1 Full Width?	N/A
N/A	Road 1 X Slope (%)	1.3	N/A	DWS 1 Offset (In)	N/A
Yes	Refuge 2 Length (In)	111.5	N/A	Gutter 2 Ponding?	N/A
Yes	Refuge 2 Width (In)	96.0	N/A	Gutter 2 Lip Ht (In)	N/A
No	Refuge 2 Slope (%)	8.0	N/A	Gutter 2 Slope (%)	N/A
Yes	Refuge 2 X Slope (%)	1.9	N/A	Gutter 2 X Slope (%)	N/A
N/A	Painted X Walk2?	Yes	N/A	DWS 2 Provided?	N/A
N/A	X Walk 2 Direction	To SE	N/A	DWS 2 Contrast?	N/A
N/A	X Walk 2 Width (In)	110.0	N/A	DWS 2 Length (In)	N/A

N/A	Road 2 Slope (%)	3.2	N/A	DWS 2 Full Width?	N/A
N/A	Road 2 X Slope (%)	1.1	N/A	DWS 2 Offset (In)	N/A
N/A	Refuge 3 Length (in)	N/A	N/A	Gutter 3 Ponding?	N/A
N/A	Refuge 3 Width (in)	N/A	N/A	Gutter 3 Lip Ht (in)	N/A
N/A	Refuge 3 Slope (%)	N/A	N/A	Gutter 3 Slope (%)	N/A
N/A	Refuge 3 XSlope (%)	N/A	N/A	Gutter 3 XSlope (%)	N/A
N/A	Painted X Walk3?	No	N/A	DWS 3 Provided?	N/A
N/A	X Walk 3 Direction	N/A	N/A	DWS 3 Contrast?	N/A
N/A	X Walk 3 Width (in)	N/A	N/A	DWS 3 Length (in)	N/A
N/A	Road 3 Slope (%)	N/A	N/A	DWS 3 Full Width?	N/A
N/A	Road 3 XSlope (%)	N/A	N/A	DWS 3 Offset (in)	N/A
Yes	Any Obstructions?	N/A	N/A	Storm Grate/Utility Hazard?	N/A
N/A	Obstruction Type		N/A	Storm Grate/Utility Type	
		N/A			N/A
N/A	Surface Condition	Good

**Remove & Replace Entire Refuge.**
