Access Compliance Report

Public Rights-of-Way

(Island Curb Cuts)

Intersection ID: 30454	Main Street: SHALOM_PARK_DR	Cross Street: PROVIDENCE_RD	Location: SE
ADA ID: 197E9FCD0DA4	Curb Cut Type: MedianRefuge2	Initial Pass/Fail: Fail	Overall Compliance: No
Codes/Mitigation Info/Possible Solution		Field Measurements/Component Compliance	
Severity Score: 0

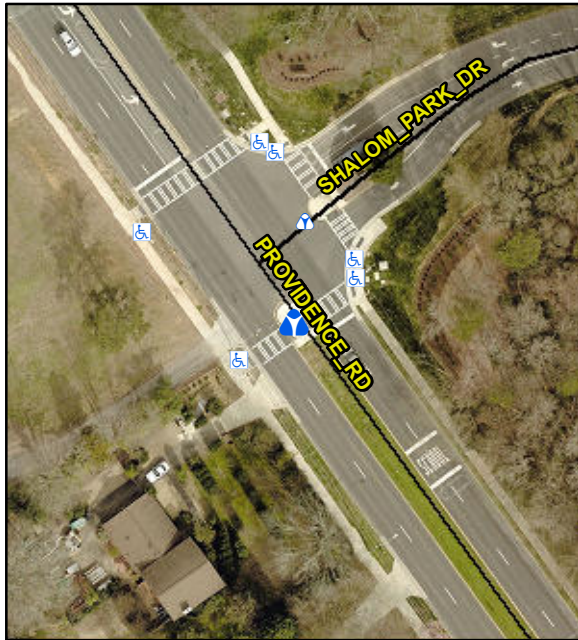
Compliance	Description	Data	Compliance	Description	Data
Yes	Refuge 1 Length (In)	78.0	N/A	Gutter 1 Ponding?	N/A
Yes	Refuge 1 Width (In)	99.0	N/A	Gutter 1 Lip Ht (In)	N/A
Yes	Refuge 1 Slope (%)	1.4	N/A	Gutter 1 Slope (%)	N/A
Yes	Refuge 1 X Slope (%)	4.1	N/A	Gutter 1 X Slope (%)	N/A
N/A	Painted X Walk1?	Yes	N/A	DWS 1 Provided?	N/A
N/A	X Walk 1 Direction	To NE	N/A	DWS 1 Contrast?	N/A
N/A	X Walk 1 Width (In)	114.0	N/A	DWS 1 Length (In)	N/A
N/A	Road 1 Slope (%)	4.4	N/A	DWS 1 Full Width?	N/A
N/A	Road 1 X Slope (%)	3.8	N/A	DWS 1 Offset (In)	N/A
Yes	Refuge 2 Length (In)	78.0	N/A	Gutter 2 Ponding?	N/A
Yes	Refuge 2 Width (In)	99.0	N/A	Gutter 2 Lip Ht (In)	N/A
Yes	Refuge 2 Slope (%)	1.1	N/A	Gutter 2 Slope (%)	N/A
Yes	Refuge 2 X Slope (%)	4.3	N/A	Gutter 2 X Slope (%)	N/A
N/A	Painted X Walk2?	Yes	N/A	DWS 2 Provided?	N/A
N/A	X Walk 2 Direction	To SW	N/A	DWS 2 Contrast?	N/A
N/A	X Walk 2 Width (In)	113.0	N/A	DWS 2 Length (In)	N/A

N/A	Road 2 Slope (%)	5.0	N/A	DWS 2 Full Width?	N/A
N/A	Road 2 X Slope (%)	3.0	N/A	DWS 2 Offset (In)	N/A
N/A	Refuge 3 Length (in)	N/A	N/A	Gutter 3 Ponding?	N/A
N/A	Refuge 3 Width (in)	N/A	N/A	Gutter 3 Lip Ht (in)	N/A
N/A	Refuge 3 Slope (%)	N/A	N/A	Gutter 3 Slope (%)	N/A
N/A	Refuge 3 XSlope (%)	N/A	N/A	Gutter 3 XSlope (%)	N/A
N/A	Painted X Walk3?	N/A	N/A	DWS 3 Provided?	N/A
N/A	X Walk 3 Direction	N/A	N/A	DWS 3 Contrast?	N/A
N/A	X Walk 3 Width (in)	N/A	N/A	DWS 3 Length (in)	N/A
N/A	Road 3 Slope (%)	N/A	N/A	DWS 3 Full Width?	N/A
N/A	Road 3 XSlope (%)	N/A	N/A	DWS 3 Offset (in)	N/A
Yes	Any Obstructions?	N/A	N/A	Storm Grate/Utility Hazard?	N/A
N/A	Obstruction Type		N/A	Storm Grate/Utility Type	
		N/A			N/A
N/A	Surface Condition	Good

Remove & Replace Entire Refuge.
