Access Compliance Report

Public Rights-of-Way

(Island Curb Cuts)

Intersection ID: 18818	Main Street: BEAM_RD	Cross Street: SHOPTON_RD	Location: S
ADA ID: 1ADC3DFA97C7	Curb Cut Type: MedianRefuge2	Initial Pass/Fail: Fail	Overall Compliance: No
Codes/Mitigation Info/Possible Solution		Field Measurements/Component Compliance	
Severity Score: 1.25

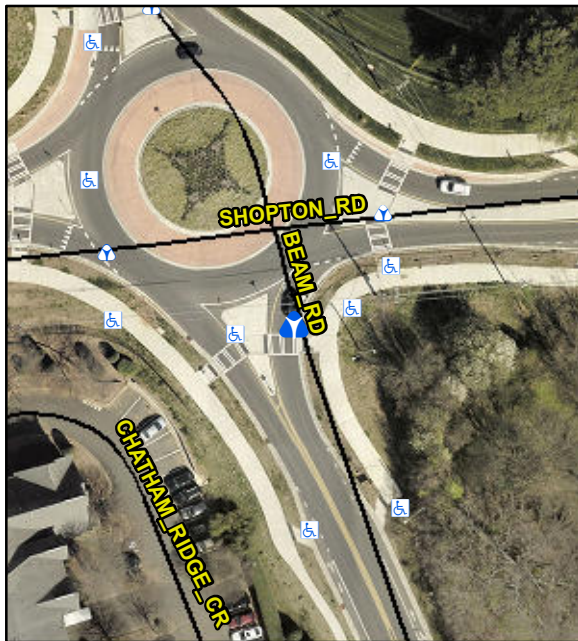
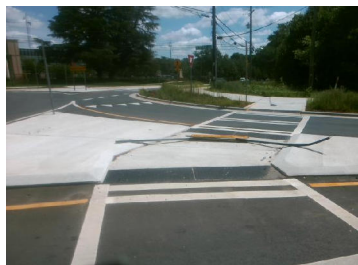
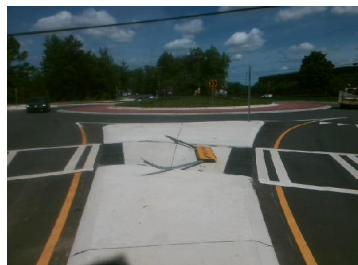
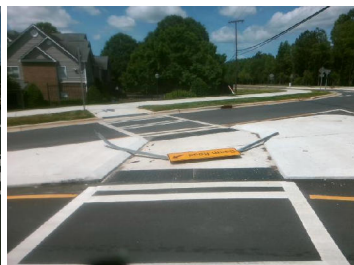
Compliance	Description	Data	Compliance	Description	Data
Yes	Refuge 1 Length (In)	79	N/A	Gutter 1 Ponding?	N/A
Yes	Refuge 1 Width (In)	123	N/A	Gutter 1 Lip Ht (In)	N/A
Yes	Refuge 1 Slope (%)	2.5	N/A	Gutter 1 Slope (%)	N/A
Yes	Refuge 1 X Slope (%)	4.5	N/A	Gutter 1 X Slope (%)	N/A
N/A	Painted X Walk1?	Yes	N/A	DWS 1 Provided?	N/A
N/A	X Walk 1 Direction	To W	N/A	DWS 1 Contrast?	N/A
N/A	X Walk 1 Width (In)	111	N/A	DWS 1 Length (In)	N/A
N/A	Road 1 Slope (%)	3.1	N/A	DWS 1 Full Width?	N/A
N/A	Road 1 X Slope (%)	1.7	N/A	DWS 1 Offset (In)	N/A
Yes	Refuge 2 Length (In)	79	N/A	Gutter 2 Ponding?	N/A
Yes	Refuge 2 Width (In)	123	N/A	Gutter 2 Lip Ht (In)	N/A
Yes	Refuge 2 Slope (%)	0.4	N/A	Gutter 2 Slope (%)	N/A
Yes	Refuge 2 X Slope (%)	1.3	N/A	Gutter 2 X Slope (%)	N/A
N/A	Painted X Walk2?	Yes	N/A	DWS 2 Provided?	N/A
N/A	X Walk 2 Direction	To E	N/A	DWS 2 Contrast?	N/A
N/A	X Walk 2 Width (In)	113	N/A	DWS 2 Length (In)	N/A
N/A	Road 2 Slope (%)	3.9	N/A	DWS 2 Full Width?	N/A

N/A	Road 2 X Slope (%)	2.6	N/A	DWS 2 Offset (In)	N/A
N/A	Refuge 3 Length (in)	N/A	N/A	Gutter 3 Ponding?	N/A
N/A	Refuge 3 Width (in)	N/A	N/A	Gutter 3 Lip Ht (in)	N/A
N/A	Refuge 3 Slope (%)	N/A	N/A	Gutter 3 Slope (%)	N/A
N/A	Refuge 3 XSlope (%)	N/A	N/A	Gutter 3 XSlope (%)	N/A
N/A	Painted X Walk3?	N/A	N/A	DWS 3 Provided?	N/A
N/A	X Walk 3 Direction	N/A	N/A	DWS 3 Contrast?	N/A
N/A	X Walk 3 Width (in)	N/A	N/A	DWS 3 Length (in)	N/A
N/A	Road 3 Slope (%)	N/A	N/A	DWS 3 Full Width?	N/A
N/A	Road 3 XSlope (%)	N/A	N/A	DWS 3 Offset (in)	N/A
Yes	Any Obstructions?	N/A	N/A	Storm Grate/Utility Hazard?	N/A
N/A	Obstruction Type		N/A	Storm Grate/Utility Type	
		N/A			N/A
N/A	Surface Condition	Good

Remove & Replace Entire Refuge.

Total Cost: \$ 3000.00
