# Access Compliance Report

## Public Rights-of-Way

### (Island Curb Cuts)

Intersection ID: 3494	Main Street: REAMES_RD	Cross Street: W_W_T_HARRIS_BV	Location: NE
ADA ID: 1BA2F4F7EEAC	Curb Cut Type: IslandRefuge3	Initial Pass/Fail: Fail	Overall Compliance: No
Codes/Mitigation Info/Possible Solution		Field Measurements/Component Compliance

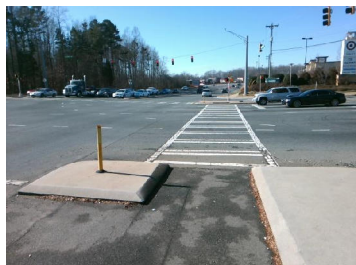
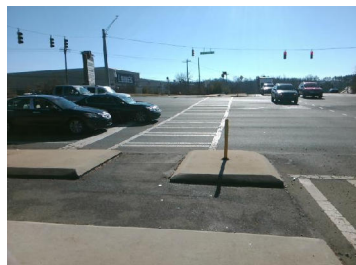
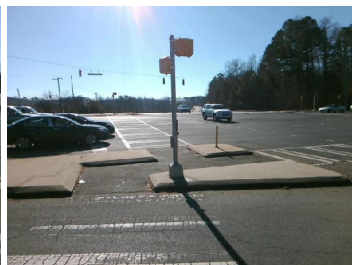
Compliance	Description	Data	Compliance	Description	Data
Yes	Refuge 1 Length (In)	83.0	N/A	Gutter 1 Ponding?	N/A
Yes	Refuge 1 Width (In)	71.0	N/A	Gutter 1 Lip Ht (In)	N/A
Yes	Refuge 1 Slope (%)	2.7	N/A	Gutter 1 Slope (%)	N/A
Yes	Refuge 1 X Slope (%)	2.5	N/A	Gutter 1 X Slope (%)	N/A
N/A	Painted X Walk1?	Yes	N/A	DWS 1 Provided?	N/A
N/A	X Walk 1 Direction	To S	N/A	DWS 1 Contrast?	N/A
N/A	X Walk 1 Width (In)	109.0	N/A	DWS 1 Length (In)	N/A
N/A	Road 1 Slope (%)	2.2	N/A	DWS 1 Full Width?	N/A
N/A	Road 1 X Slope (%)	3.4	N/A	DWS 1 Offset (In)	N/A
Yes	Refuge 2 Length (In)	83.0	N/A	Gutter 2 Ponding?	N/A
Yes	Refuge 2 Width (In)	71.0	N/A	Gutter 2 Lip Ht (In)	N/A
Yes	Refuge 2 Slope (%)	2.1	N/A	Gutter 2 Slope (%)	N/A
Yes	Refuge 2 X Slope (%)	2.6	N/A	Gutter 2 X Slope (%)	N/A
N/A	Painted X Walk2?	Yes	N/A	DWS 2 Provided?	N/A
N/A	X Walk 2 Direction	To W	N/A	DWS 2 Contrast?	N/A
N/A	X Walk 2 Width (In)	109.0	N/A	DWS 2 Length (In)	N/A

N/A	Road 2 Slope (%)	2.1	N/A	DWS 2 Full Width?	N/A
N/A	Road 2 X Slope (%)	2.6	N/A	DWS 2 Offset (In)	N/A
Yes	Refuge 3 Length (in)	48.0	N/A	Gutter 3 Ponding?	N/A
Yes	Refuge 3 Width (in)	71.0	N/A	Gutter 3 Lip Ht (in)	N/A
Yes	Refuge 3 Slope (%)	4.1	N/A	Gutter 3 Slope (%)	N/A
Yes	Refuge 3 XSlope (%)	2.5	N/A	Gutter 3 XSlope (%)	N/A
N/A	Painted X Walk3?	Yes	N/A	DWS 3 Provided?	N/A
N/A	X Walk 3 Direction	To N	N/A	DWS 3 Contrast?	N/A
N/A	X Walk 3 Width (in)	123.0	N/A	DWS 3 Length (in)	N/A
N/A	Road 3 Slope (%)	2.4	N/A	DWS 3 Full Width?	N/A
N/A	Road 3 XSlope (%)	0.1	N/A	DWS 3 Offset (in)	N/A
Yes	Any Obstructions?	N/A	N/A	Storm Grate/Utility Hazard?	N/A
N/A	Obstruction Type		N/A	Storm Grate/Utility Type	
			N/A		N/A
N/A	Surface Condition	Good

**Remove & Replace Entire Refuge.**
