Access Compliance Report

Public Rights-of-Way

(Island Curb Cuts)

Intersection ID: N/A	Main Street: E STONEWALL ST	Cross Street: S MCDOWELLNST	Location: SE
ADA ID: 1BD38DDAEC97	Curb Cut Type: MedianRefuge2	Initial Pass/Fail: Fail	Overall Compliance: No
Codes/Mitigation Info/Possible Solution		Field Measurements/Component Compliance	
Severity Score: 0

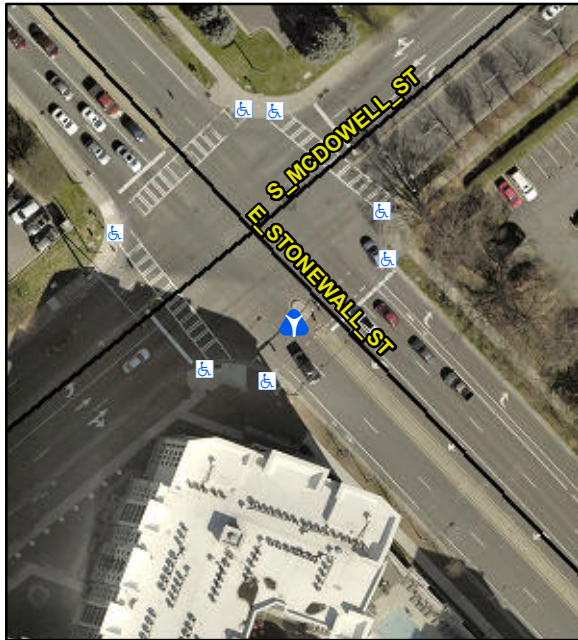
Compliance	Description	Data	Compliance	Description	Data
Yes	Refuge 1 Length (In)	36.0	N/A	Gutter 1 Ponding?	N/A
Yes	Refuge 1 Width (In)	93.0	N/A	Gutter 1 Lip Ht (In)	N/A
Yes	Refuge 1 Slope (%)	0.3	N/A	Gutter 1 Slope (%)	N/A
Yes	Refuge 1 X Slope (%)	3.3	N/A	Gutter 1 X Slope (%)	N/A
N/A	Painted X Walk1?	Yes	N/A	DWS 1 Provided?	N/A
N/A	X Walk 1 Direction	To NE	N/A	DWS 1 Contrast?	N/A
N/A	X Walk 1 Width (In)	124.0	N/A	DWS 1 Length (In)	N/A
N/A	Road 1 Slope (%)	2.6	N/A	DWS 1 Full Width?	N/A
N/A	Road 1 X Slope (%)	3.8	N/A	DWS 1 Offset (In)	N/A
Yes	Refuge 2 Length (In)	36.0	N/A	Gutter 2 Ponding?	N/A
Yes	Refuge 2 Width (In)	93.0	N/A	Gutter 2 Lip Ht (In)	N/A
Yes	Refuge 2 Slope (%)	0.3	N/A	Gutter 2 Slope (%)	N/A
Yes	Refuge 2 X Slope (%)	2.8	N/A	Gutter 2 X Slope (%)	N/A
N/A	Painted X Walk2?	Yes	N/A	DWS 2 Provided?	N/A
N/A	X Walk 2 Direction	To SW	N/A	DWS 2 Contrast?	N/A
N/A	X Walk 2 Width (In)	127.0	N/A	DWS 2 Length (In)	N/A

N/A	Road 2 Slope (%)	3.4	N/A	DWS 2 Full Width?	N/A
N/A	Road 2 X Slope (%)	1.4	N/A	DWS 2 Offset (In)	N/A
N/A	Refuge 3 Length (in)	N/A	N/A	Gutter 3 Ponding?	N/A
N/A	Refuge 3 Width (in)	N/A	N/A	Gutter 3 Lip Ht (in)	N/A
N/A	Refuge 3 Slope (%)	N/A	N/A	Gutter 3 Slope (%)	N/A
N/A	Refuge 3 XSlope (%)	N/A	N/A	Gutter 3 XSlope (%)	N/A
N/A	Painted X Walk3?	N/A	N/A	DWS 3 Provided?	N/A
N/A	X Walk 3 Direction	N/A	N/A	DWS 3 Contrast?	N/A
N/A	X Walk 3 Width (in)	N/A	N/A	DWS 3 Length (in)	N/A
N/A	Road 3 Slope (%)	N/A	N/A	DWS 3 Full Width?	N/A
N/A	Road 3 XSlope (%)	N/A	N/A	DWS 3 Offset (in)	N/A
Yes	Any Obstructions?	N/A	N/A	Storm Grate/Utility Hazard?	N/A
N/A	Obstruction Type		N/A	Storm Grate/Utility Type	
		N/A			N/A
N/A	Surface Condition	Good

Possible Solutions:

Remove & Replace Entire Refuge.
