Access Compliance Report

Public Rights-of-Way

(Island Curb Cuts)

Intersection ID: 49333	Main Street: MARGARET_WALLACE_RD	Cross Street: MINTWORTH_AV	Location: NW
ADA ID: 1FC3DEAD190B	Curb Cut Type: MedianRefuge2	Initial Pass/Fail: Fail	Overall Compliance: No
Severity Score: 17.5			
Codes/Mitigation Info/Possible Solution		Field Measurements/Component Compliance

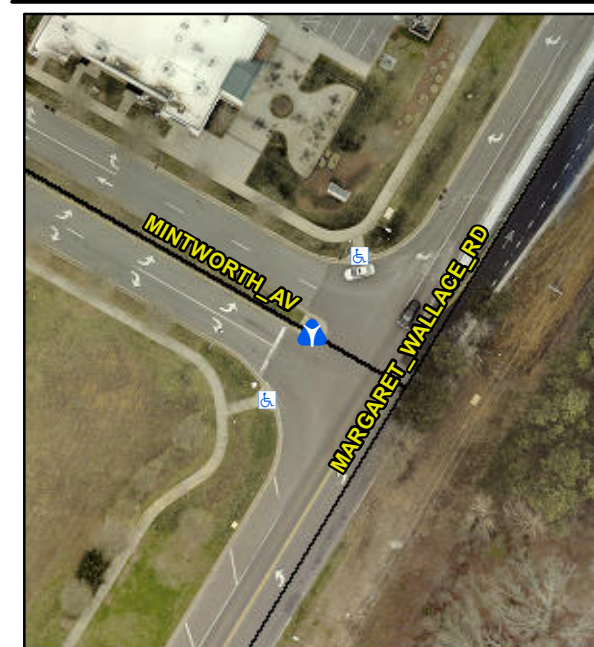
Compliance	Description	Data	Compliance	Description	Data
Yes	Refuge 1 Length (In)	55.5	N/A	Gutter 1 Ponding?	N/A
No	Refuge 1 Width (In)	47.0	N/A	Gutter 1 Lip Ht (In)	N/A
Yes	Refuge 1 Slope (%)	1.2	N/A	Gutter 1 Slope (%)	N/A
Yes	Refuge 1 X Slope (%)	4.4	N/A	Gutter 1 X Slope (%)	N/A
N/A	Painted X Walk1?	No	N/A	DWS 1 Provided?	N/A
N/A	X Walk 1 Direction	To SW	N/A	DWS 1 Contrast?	N/A
N/A	X Walk 1 Width (In)	N/A	N/A	DWS 1 Length (In)	N/A
N/A	Road 1 Slope (%)	4.7	N/A	DWS 1 Full Width?	N/A
N/A	Road 1 X Slope (%)	1.4	N/A	DWS 1 Offset (In)	N/A
Yes	Refuge 2 Length (In)	55.5	N/A	Gutter 2 Ponding?	N/A
No	Refuge 2 Width (In)	47.0	N/A	Gutter 2 Lip Ht (In)	N/A
Yes	Refuge 2 Slope (%)	1.3	N/A	Gutter 2 Slope (%)	N/A
Yes	Refuge 2 X Slope (%)	2.8	N/A	Gutter 2 X Slope (%)	N/A
N/A	Painted X Walk2?	No	N/A	DWS 2 Provided?	N/A
N/A	X Walk 2 Direction	To NE	N/A	DWS 2 Contrast?	N/A
N/A	X Walk 2 Width (In)	N/A	N/A	DWS 2 Length (In)	N/A

N/A	Road 2 Slope (%)	3.7	N/A	DWS 2 Full Width?	N/A
N/A	Road 2 X Slope (%)	1.6	N/A	DWS 2 Offset (In)	N/A
N/A	Refuge 3 Length (in)	N/A	N/A	Gutter 3 Ponding?	N/A
N/A	Refuge 3 Width (in)	N/A	N/A	Gutter 3 Lip Ht (in)	N/A
N/A	Refuge 3 Slope (%)	N/A	N/A	Gutter 3 Slope (%)	N/A
N/A	Refuge 3 XSlope (%)	N/A	N/A	Gutter 3 XSlope (%)	N/A
N/A	Painted X Walk3?	N/A	N/A	DWS 3 Provided?	N/A
N/A	X Walk 3 Direction	N/A	N/A	DWS 3 Contrast?	N/A
N/A	X Walk 3 Width (in)	N/A	N/A	DWS 3 Length (in)	N/A
N/A	Road 3 Slope (%)	N/A	N/A	DWS 3 Full Width?	N/A
N/A	Road 3 XSlope (%)	N/A	N/A	DWS 3 Offset (in)	N/A
Yes	Any Obstructions?	N/A	N/A	Storm Grate/Utility Hazard?	N/A
N/A	Obstruction Type		N/A	Storm Grate/Utility Type	
		N/A			N/A
N/A	Surface Condition	Good

Possible Solutions:

Remove & Replace Entire Refuge.
