# Access Compliance Report

## Public Rights-of-Way

### (Island Curb Cuts)

Intersection ID: 10003849	Main Street: DIXIE_RIVER_RD	Cross Street: NEW_FASHION_WY	Location: E
ADA ID: 2146A4D7DC2D	Curb Cut Type: MedianRefuge2	Initial Pass/Fail: Fail	Overall Compliance: No
Codes/Mitigation Info/Possible Solution		Field Measurements/Component Compliance

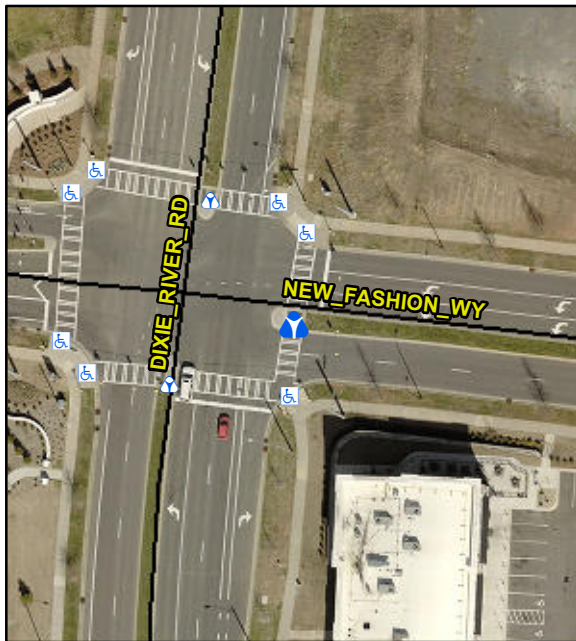
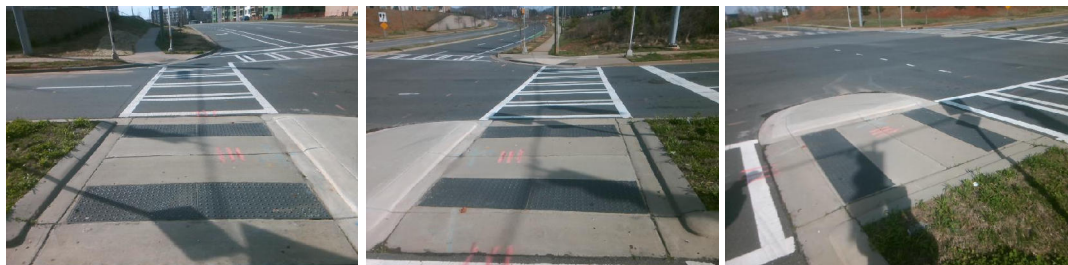
Compliance	Description	Data	Compliance	Description	Data
Yes	Refuge 1 Length (In)	53.0	N/A	Gutter 1 Ponding?	N/A
Yes	Refuge 1 Width (In)	116.0	N/A	Gutter 1 Lip Ht (In)	N/A
Yes	Refuge 1 Slope (%)	0.2	N/A	Gutter 1 Slope (%)	N/A
Yes	Refuge 1 X Slope (%)	4.5	N/A	Gutter 1 X Slope (%)	N/A
N/A	Painted X Walk1?	Yes	N/A	DWS 1 Provided?	N/A
N/A	X Walk 1 Direction	To S	N/A	DWS 1 Contrast?	N/A
N/A	X Walk 1 Width (In)	110.0	N/A	DWS 1 Length (In)	N/A
N/A	Road 1 Slope (%)	3.5	N/A	DWS 1 Full Width?	N/A
N/A	Road 1 X Slope (%)	1.5	N/A	DWS 1 Offset (In)	N/A
Yes	Refuge 2 Length (In)	53.0	N/A	Gutter 2 Ponding?	N/A
Yes	Refuge 2 Width (In)	116.0	N/A	Gutter 2 Lip Ht (In)	N/A
Yes	Refuge 2 Slope (%)	1.1	N/A	Gutter 2 Slope (%)	N/A
Yes	Refuge 2 X Slope (%)	3.7	N/A	Gutter 2 X Slope (%)	N/A
N/A	Painted X Walk2?	Yes	N/A	DWS 2 Provided?	N/A
N/A	X Walk 2 Direction	To N	N/A	DWS 2 Contrast?	N/A
N/A	X Walk 2 Width (In)	111.0	N/A	DWS 2 Length (In)	N/A

N/A	Road 2 Slope (%)	4.3	N/A	DWS 2 Full Width?	N/A
N/A	Road 2 X Slope (%)	4.7	N/A	DWS 2 Offset (In)	N/A
N/A	Refuge 3 Length (in)	N/A	N/A	Gutter 3 Ponding?	N/A
N/A	Refuge 3 Width (in)	N/A	N/A	Gutter 3 Lip Ht (in)	N/A
N/A	Refuge 3 Slope (%)	N/A	N/A	Gutter 3 Slope (%)	N/A
N/A	Refuge 3 XSlope (%)	N/A	N/A	Gutter 3 XSlope (%)	N/A
N/A	Painted X Walk3?	N/A	N/A	DWS 3 Provided?	N/A
N/A	X Walk 3 Direction	N/A	N/A	DWS 3 Contrast?	N/A
N/A	X Walk 3 Width (in)	N/A	N/A	DWS 3 Length (in)	N/A
N/A	Road 3 Slope (%)	N/A	N/A	DWS 3 Full Width?	N/A
N/A	Road 3 XSlope (%)	N/A	N/A	DWS 3 Offset (in)	N/A
Yes	Any Obstructions?	N/A	N/A	Storm Grate/Utility Hazard?	N/A
N/A	Obstruction Type		N/A	Storm Grate/Utility Type	
		N/A			N/A
N/A	Surface Condition	Good

Possible Solutions:

**Remove & Replace Entire Refuge.**

Total Cost: \$ 3000.00
