Access Compliance Report

Public Rights-of-Way

(Island Curb Cuts)

Intersection ID: 13936	Main Street: S_KINGS_DR	Cross Street: CHARLOTTETOWNE_AV	Location: NE
ADA ID: 2328B95C0FB3	Curb Cut Type: MedianRefuge2	Initial Pass/Fail: Fail	Overall Compliance: No
Severity Score: 13.75			
Codes/Mitigation Info/Possible Solution		Field Measurements/Component Compliance

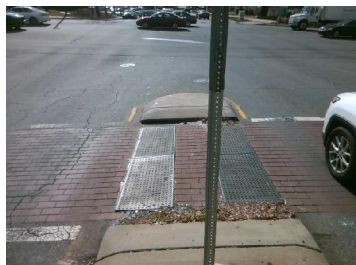
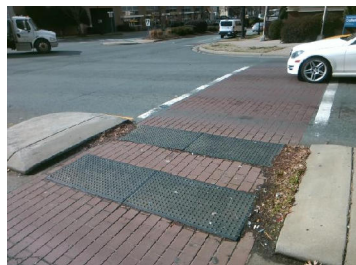
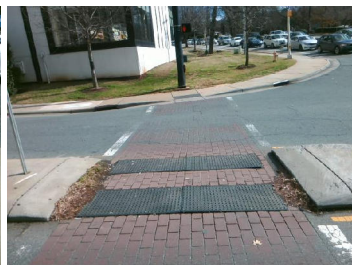
Compliance	Description	Data	Compliance	Description	Data
Yes	Refuge 1 Length (In)	37.0	N/A	Gutter 1 Ponding?	N/A
Yes	Refuge 1 Width (In)	120.0	N/A	Gutter 1 Lip Ht (In)	N/A
Yes	Refuge 1 Slope (%)	3.0	N/A	Gutter 1 Slope (%)	N/A
No	Refuge 1 X Slope (%)	6.0	N/A	Gutter 1 X Slope (%)	N/A
N/A	Painted X Walk1?	Yes	N/A	DWS 1 Provided?	N/A
N/A	X Walk 1 Direction	To SE	N/A	DWS 1 Contrast?	N/A
N/A	X Walk 1 Width (In)	118.0	N/A	DWS 1 Length (In)	N/A
N/A	Road 1 Slope (%)	3.0	N/A	DWS 1 Full Width?	N/A
N/A	Road 1 X Slope (%)	2.7	N/A	DWS 1 Offset (In)	N/A
Yes	Refuge 2 Length (In)	37.0	N/A	Gutter 2 Ponding?	N/A
Yes	Refuge 2 Width (In)	120.0	N/A	Gutter 2 Lip Ht (In)	N/A
Yes	Refuge 2 Slope (%)	0.5	N/A	Gutter 2 Slope (%)	N/A
No	Refuge 2 X Slope (%)	6.3	N/A	Gutter 2 X Slope (%)	N/A
N/A	Painted X Walk2?	Yes	N/A	DWS 2 Provided?	N/A
N/A	X Walk 2 Direction	To NW	N/A	DWS 2 Contrast?	N/A
N/A	X Walk 2 Width (In)	112.0	N/A	DWS 2 Length (In)	N/A

Remove & Replace Entire Refuge.
