Access Compliance Report

Public Rights-of-Way

(Island Curb Cuts)

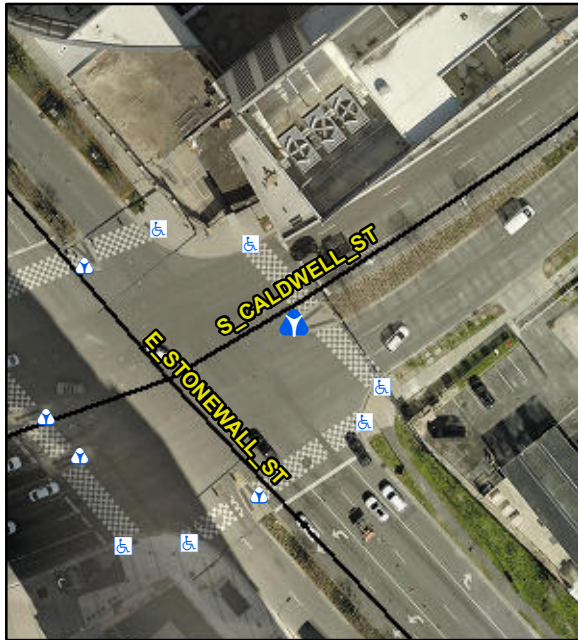
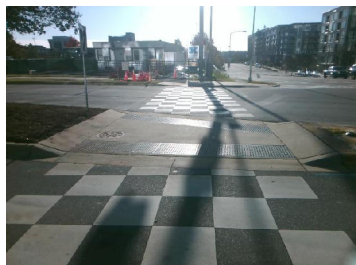
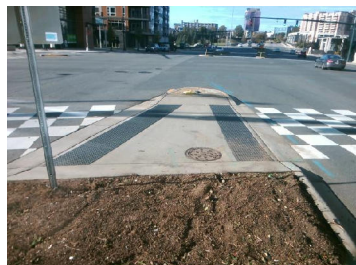
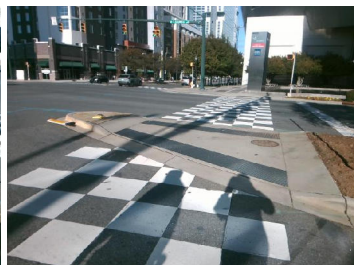
Intersection ID: N/A	Main Street: E STONEWALL ST	Cross Street: S CALDWELL ST	Location: E
ADA ID: 24388A308BFD	Curb Cut Type: MedianRefuge2	Initial Pass/Fail: Fail	Overall Compliance: No
Codes/Mitigation Info/Possible Solution		Field Measurements/Component Compliance	
Severity Score: 0

Compliance	Description	Data	Compliance	Description	Data
Yes	Refuge 1 Length (In)	45.0	N/A	Gutter 1 Ponding?	N/A
Yes	Refuge 1 Width (In)	157.0	N/A	Gutter 1 Lip Ht (In)	N/A
Yes	Refuge 1 Slope (%)	0.3	N/A	Gutter 1 Slope (%)	N/A
Yes	Refuge 1 X Slope (%)	2.2	N/A	Gutter 1 X Slope (%)	N/A
N/A	Painted X Walk1?	Yes	N/A	DWS 1 Provided?	N/A
N/A	X Walk 1 Direction	To NW	N/A	DWS 1 Contrast?	N/A
N/A	X Walk 1 Width (In)	144.0	N/A	DWS 1 Length (In)	N/A
N/A	Road 1 Slope (%)	1.9	N/A	DWS 1 Full Width?	N/A
N/A	Road 1 X Slope (%)	0.8	N/A	DWS 1 Offset (In)	N/A
Yes	Refuge 2 Length (In)	45.0	N/A	Gutter 2 Ponding?	N/A
Yes	Refuge 2 Width (In)	157.0	N/A	Gutter 2 Lip Ht (In)	N/A
Yes	Refuge 2 Slope (%)	0.8	N/A	Gutter 2 Slope (%)	N/A
Yes	Refuge 2 X Slope (%)	2.1	N/A	Gutter 2 X Slope (%)	N/A
N/A	Painted X Walk2?	Yes	N/A	DWS 2 Provided?	N/A
N/A	X Walk 2 Direction	To SE	N/A	DWS 2 Contrast?	N/A
N/A	X Walk 2 Width (In)	144.0	N/A	DWS 2 Length (In)	N/A

N/A	Road 2 Slope (%)	0.8	N/A	DWS 2 Full Width?	N/A
N/A	Road 2 X Slope (%)	2.9	N/A	DWS 2 Offset (In)	N/A
N/A	Refuge 3 Length (in)	N/A	N/A	Gutter 3 Ponding?	N/A
N/A	Refuge 3 Width (in)	N/A	N/A	Gutter 3 Lip Ht (in)	N/A
N/A	Refuge 3 Slope (%)	N/A	N/A	Gutter 3 Slope (%)	N/A
N/A	Refuge 3 XSlope (%)	N/A	N/A	Gutter 3 XSlope (%)	N/A
N/A	Painted X Walk3?	N/A	N/A	DWS 3 Provided?	N/A
N/A	X Walk 3 Direction	N/A	N/A	DWS 3 Contrast?	N/A
N/A	X Walk 3 Width (in)	N/A	N/A	DWS 3 Length (in)	N/A
N/A	Road 3 Slope (%)	N/A	N/A	DWS 3 Full Width?	N/A
N/A	Road 3 XSlope (%)	N/A	N/A	DWS 3 Offset (in)	N/A
Yes	Any Obstructions?	N/A	N/A	Storm Grate/Utility Hazard?	N/A
N/A	Obstruction Type		N/A	Storm Grate/Utility Type	
		N/A			N/A
N/A	Surface Condition	Good

Possible Solutions:

Remove & Replace Entire Refuge.

Total Cost: \$ 3000.00
