Access Compliance Report

Public Rights-of-Way

(Island Curb Cuts)

Intersection ID: 25609	Main Street: RAINTREE_LN	Cross Street: ROUNDING_RUN_RD	Location: N
ADA ID: 247F9DA7DF8B	Curb Cut Type: MedianRefuge2	Initial Pass/Fail: Fail	Overall Compliance: No
Severity Score: 8.75			
Codes/Mitigation Info/Possible Solution		Field Measurements/Component Compliance

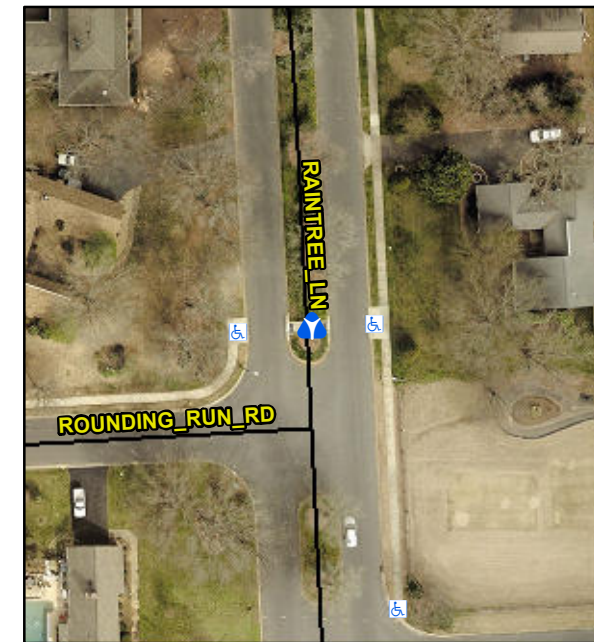
Compliance	Description	Data	Compliance	Description	Data
Yes	Refuge 1 Length (In)	116.0	N/A	Gutter 1 Ponding?	N/A
No	Refuge 1 Width (In)	59.0	N/A	Gutter 1 Lip Ht (In)	N/A
Yes	Refuge 1 Slope (%)	1.4	N/A	Gutter 1 Slope (%)	N/A
Yes	Refuge 1 X Slope (%)	2.5	N/A	Gutter 1 X Slope (%)	N/A
N/A	Painted X Walk1?	No	N/A	DWS 1 Provided?	N/A
N/A	X Walk 1 Direction	To W	N/A	DWS 1 Contrast?	N/A
N/A	X Walk 1 Width (In)	N/A	N/A	DWS 1 Length (In)	N/A
N/A	Road 1 Slope (%)	2.7	N/A	DWS 1 Full Width?	N/A
N/A	Road 1 X Slope (%)	2.8	N/A	DWS 1 Offset (In)	N/A
Yes	Refuge 2 Length (In)	116.0	N/A	Gutter 2 Ponding?	N/A
No	Refuge 2 Width (In)	59.0	N/A	Gutter 2 Lip Ht (In)	N/A
Yes	Refuge 2 Slope (%)	1.5	N/A	Gutter 2 Slope (%)	N/A
Yes	Refuge 2 X Slope (%)	2.8	N/A	Gutter 2 X Slope (%)	N/A
N/A	Painted X Walk2?	No	N/A	DWS 2 Provided?	N/A
N/A	X Walk 2 Direction	To E	N/A	DWS 2 Contrast?	N/A
N/A	X Walk 2 Width (In)	N/A	N/A	DWS 2 Length (In)	N/A

N/A	Road 2 Slope (%)	2.9	N/A	DWS 2 Full Width?	N/A
N/A	Road 2 X Slope (%)	1.1	N/A	DWS 2 Offset (In)	N/A
N/A	Refuge 3 Length (in)	N/A	N/A	Gutter 3 Ponding?	N/A
N/A	Refuge 3 Width (in)	N/A	N/A	Gutter 3 Lip Ht (in)	N/A
N/A	Refuge 3 Slope (%)	N/A	N/A	Gutter 3 Slope (%)	N/A
N/A	Refuge 3 XSlope (%)	N/A	N/A	Gutter 3 XSlope (%)	N/A
N/A	Painted X Walk3?	N/A	N/A	DWS 3 Provided?	N/A
N/A	X Walk 3 Direction	N/A	N/A	DWS 3 Contrast?	N/A
N/A	X Walk 3 Width (in)	N/A	N/A	DWS 3 Length (in)	N/A
N/A	Road 3 Slope (%)	N/A	N/A	DWS 3 Full Width?	N/A
N/A	Road 3 XSlope (%)	N/A	N/A	DWS 3 Offset (in)	N/A
Yes	Any Obstructions?	N/A	N/A	Storm Grate/Utility Hazard?	N/A
N/A	Obstruction Type		N/A	Storm Grate/Utility Type	
		N/A			N/A
N/A	Surface Condition	Good

Possible Solutions:

Remove & Replace Entire Refuge.
