Access Compliance Report

Public Rights-of-Way

(Island Curb Cuts)

Intersection ID: 52100	Main Street: FRED_D_ALEXANDER_BV	Cross Street: FREEDOM_DR	Location: SW
ADA ID: 29F4427E2EDD	Curb Cut Type: MedianRefuge2	Initial Pass/Fail: Fail	Overall Compliance: No
Severity Score: 1.25			
Codes/Mitigation Info/Possible Solution		Field Measurements/Component Compliance

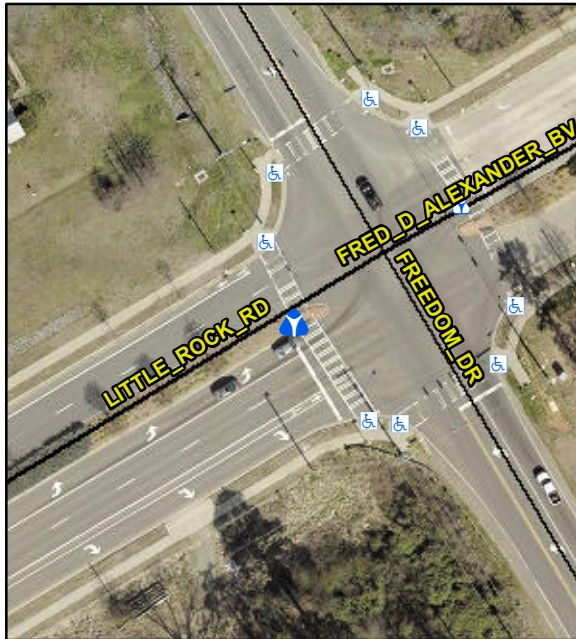
Compliance	Description	Data	Compliance	Description	Data
Yes	Refuge 1 Length (In)	45.0	N/A	Gutter 1 Ponding?	N/A
Yes	Refuge 1 Width (In)	93.5	N/A	Gutter 1 Lip Ht (In)	N/A
Yes	Refuge 1 Slope (%)	2.6	N/A	Gutter 1 Slope (%)	N/A
Yes	Refuge 1 X Slope (%)	1.5	N/A	Gutter 1 X Slope (%)	N/A
N/A	Painted X Walk1?	Yes	N/A	DWS 1 Provided?	N/A
N/A	X Walk 1 Direction	To SW	N/A	DWS 1 Contrast?	N/A
N/A	X Walk 1 Width (In)	112.0	N/A	DWS 1 Length (In)	N/A
N/A	Road 1 Slope (%)	2.2	N/A	DWS 1 Full Width?	N/A
N/A	Road 1 X Slope (%)	3.1	N/A	DWS 1 Offset (In)	N/A
Yes	Refuge 2 Length (In)	45.0	N/A	Gutter 2 Ponding?	N/A
Yes	Refuge 2 Width (In)	93.5	N/A	Gutter 2 Lip Ht (In)	N/A
Yes	Refuge 2 Slope (%)	0.9	N/A	Gutter 2 Slope (%)	N/A
Yes	Refuge 2 X Slope (%)	2.4	N/A	Gutter 2 X Slope (%)	N/A
N/A	Painted X Walk2?	Yes	N/A	DWS 2 Provided?	N/A
N/A	X Walk 2 Direction	To NW	N/A	DWS 2 Contrast?	N/A
N/A	X Walk 2 Width (In)	111.0	N/A	DWS 2 Length (In)	N/A

N/A	Road 2 Slope (%)	1.5	N/A	DWS 2 Full Width?	N/A
N/A	Road 2 X Slope (%)	2.2	N/A	DWS 2 Offset (In)	N/A
N/A	Refuge 3 Length (in)	N/A	N/A	Gutter 3 Ponding?	N/A
N/A	Refuge 3 Width (in)	N/A	N/A	Gutter 3 Lip Ht (in)	N/A
N/A	Refuge 3 Slope (%)	N/A	N/A	Gutter 3 Slope (%)	N/A
N/A	Refuge 3 XSlope (%)	N/A	N/A	Gutter 3 XSlope (%)	N/A
N/A	Painted X Walk3?	N/A	N/A	DWS 3 Provided?	N/A
N/A	X Walk 3 Direction	N/A	N/A	DWS 3 Contrast?	N/A
N/A	X Walk 3 Width (in)	N/A	N/A	DWS 3 Length (in)	N/A
N/A	Road 3 Slope (%)	N/A	N/A	DWS 3 Full Width?	N/A
N/A	Road 3 XSlope (%)	N/A	N/A	DWS 3 Offset (in)	N/A
Yes	Any Obstructions?	N/A	N/A	Storm Grate/Utility Hazard?	N/A
N/A	Obstruction Type		N/A	Storm Grate/Utility Type	
		N/A			N/A
N/A	Surface Condition	Good

Possible Solutions:

Remove & Replace Entire Refuge.
